## CRYOCOOLER SERVICE REPORT

**Beamline:** 11

**Vessel serial no:** AMG00100/S3-BESSRC                      **Pump serial no:** 3E95

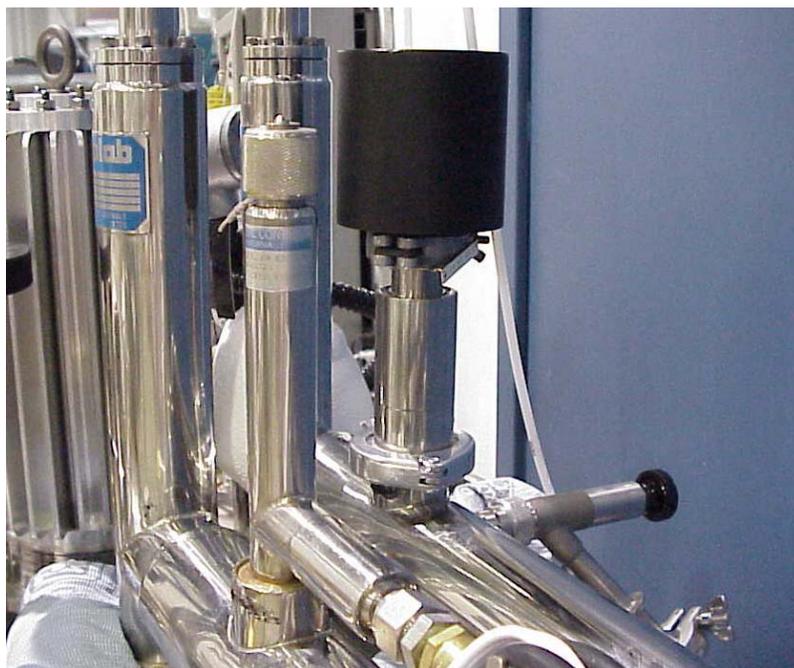
On or around October 28, 2004, a relatively large ball of ice existed on the LN<sub>2</sub> supply side bayonet fitting which partially covered the vacuum clamp that fastens the rupture disk to the bayonet. The ice ball also covered a portion of the low pressure vent line and the SK-2 wire harness that provides power for the pump motor. The photo in Figure 1 shows the area of the rupture disk after the ice ball had dissipated.

Fig. 1: Close-up of bayonets and rupture disk clamp after ice ball was dissipated

The above information indicates that the possible cause of the leaky bayonet is the O-ring on the pump out port. The valve and pump will be disconnected in the near future. If the ice-ball returns to the bayonet area, the O-ring will have to be repaired during the next shutdown period.

A Dry-tel vacuum pump was connected to the bayonet with an appropriate pumpout valve. The pump was operated overnight causing the ice around the rupture disk to dissipate by the next day. At that time, the pumpout valve was closed but the valve and pump were left mechanically connected to the bayonet. To date (11-05-04) the ice on the bayonet has not returned.

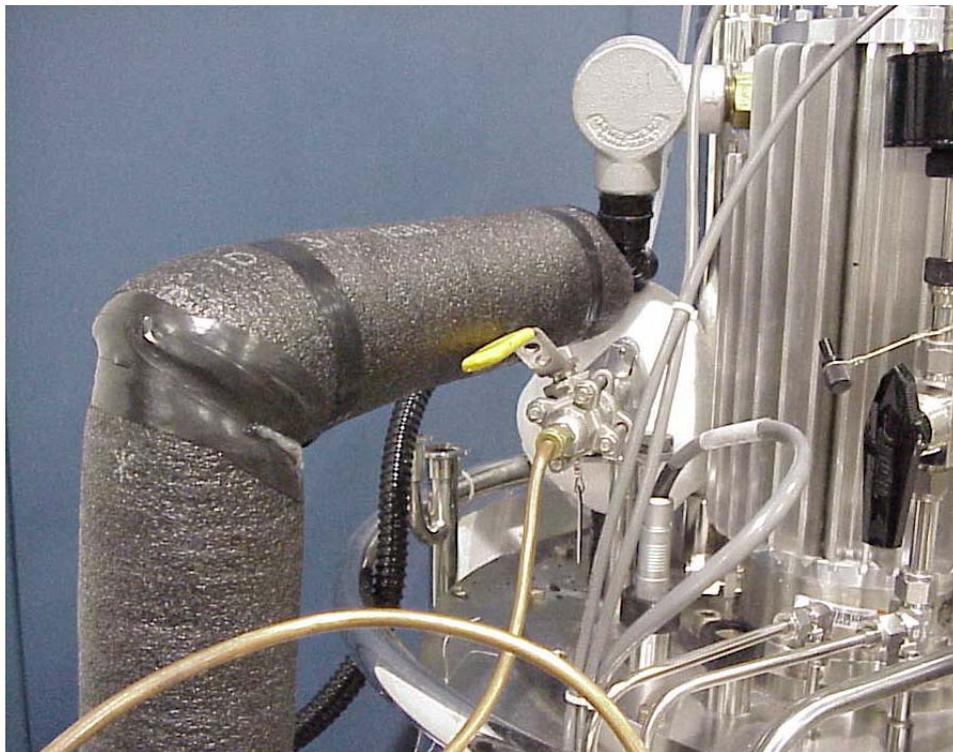
After the ice ball around the rupture disk area had dissipated, it was noticed that the ice around the low pressure vent was still present and that the SK-2 power harness for the pump was enveloped by the remaining ice and residual water. A hot air blower was used to reduce the size of the remaining ice so that the harness could be relocated to a less hazardous position. It is known that leaving this harness in the ice/water mixture could result in damage.

Fig. 2: Ice ball remaining on vent line.

The ice ball on the vent line is still present. The next time the unit is serviced, the integrity of the vent line should be improved to eliminate the ice ball. Figure 2 is a photo of the ice ball.
