Safety Inspection of 10/15/03 by E. Gluskin and J. Alicz

Sector 7 LOM Office Area

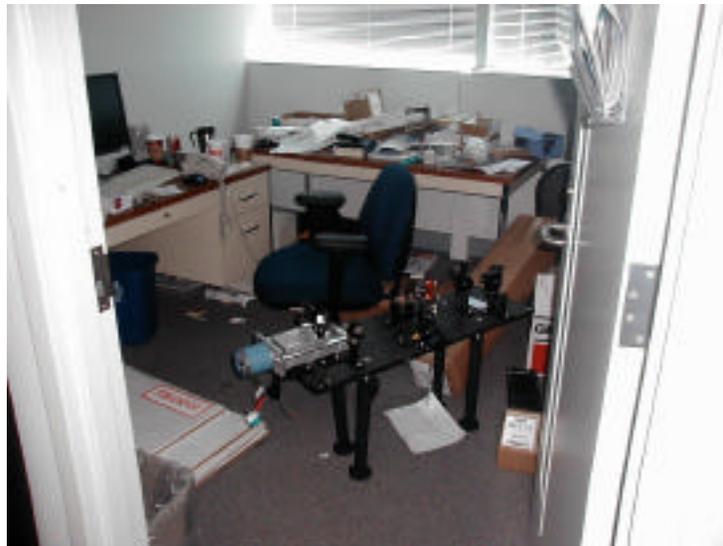
1. Noteworthy Practice: The general area was found to be in good order.
2. The office needs improved housekeeping, and the experimental setup in the office does not appear to be in a stable condition (see photo below).

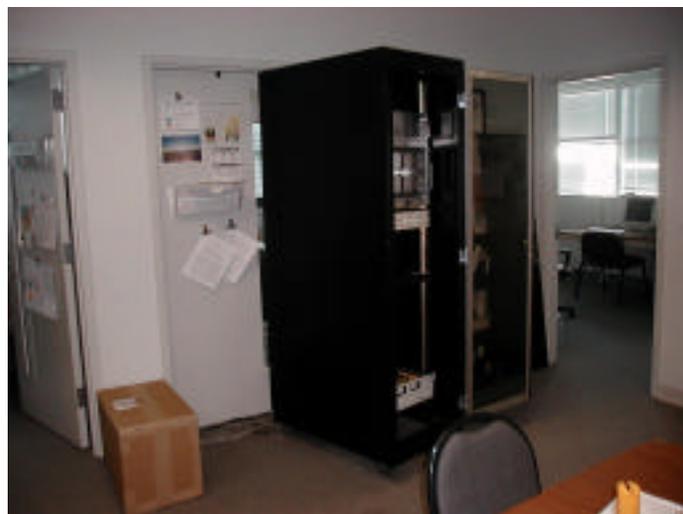
3. The electrical rack located in front of an office door should be repositioned to provide easier access to and from the office (see photo below).

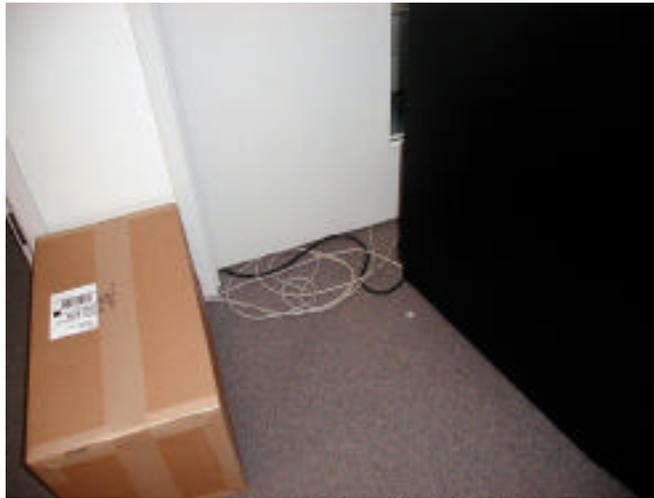
Also, the cables from the electrical rack should be repositioned so that they do not create a tripping hazard in front of the office door (see photo below).

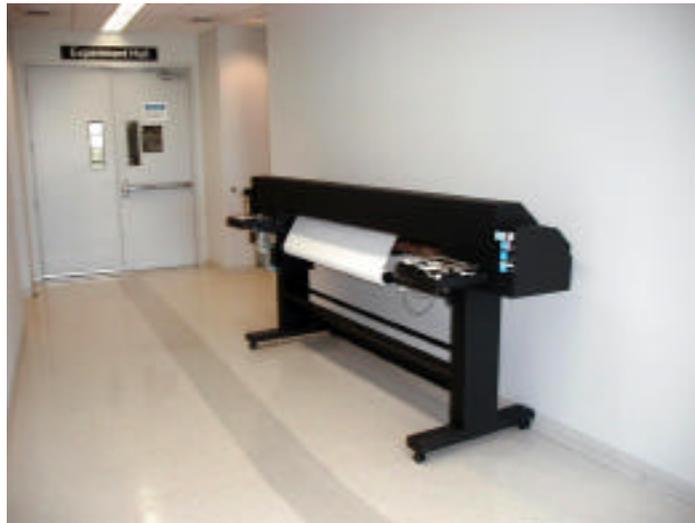
4. Reminder: Empty boxes should be removed from the area.
5. The plotter in the hallway also needs to be relocated to a more suitable storage area (see photo below).

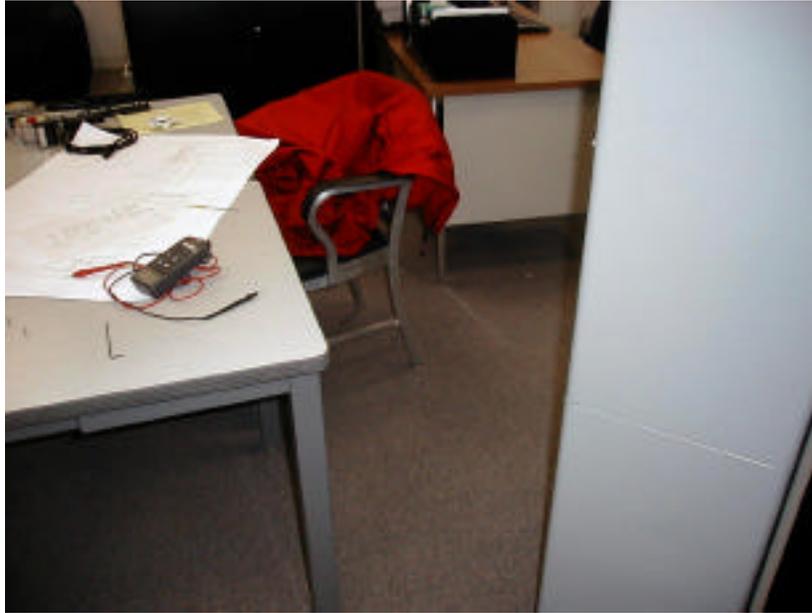
1. The table needs to be repositioned to create a wider aisle between the table and the bookshelf (see photo next page). **Note: this item was immediately corrected.**
