Safety Inspection of 11/26/03 by E. Gluskin and J. Alicz

Sector 7 Beamlines

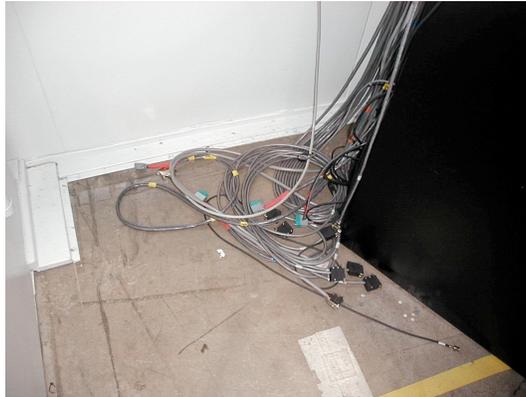
1. Cables on floor downstream from 7-ID-B need to be better organized (see photo below).

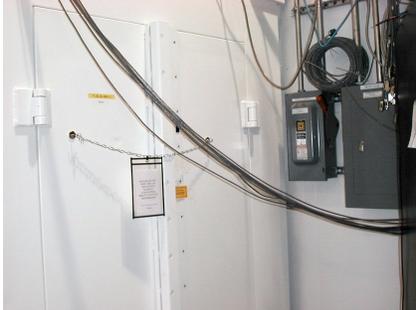
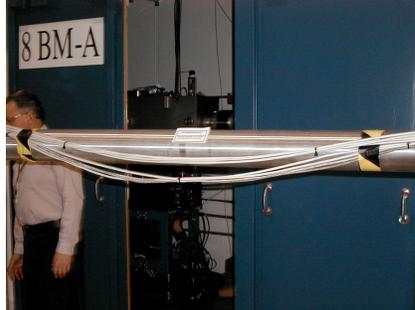
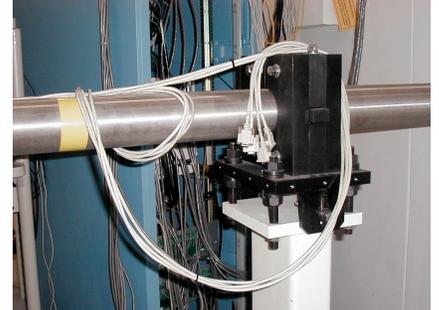
2. Overhead cable trays should be installed to accommodate hanging cables and cables attached to beam pipes (see photos below).

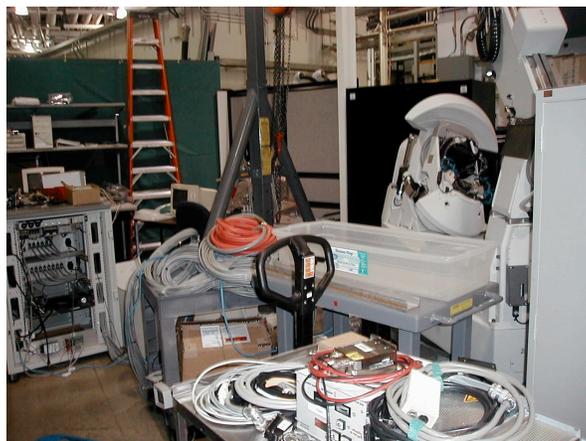
3. General housekeeping in this area requires improvement (see photo below).
