RF Electron Gun Mechanical Repair

Bill Jansma, Engineering Specialist Advanced Photon Source Argonne National Laboratory

2013 APS Accelerator Systems Division Seminar Series

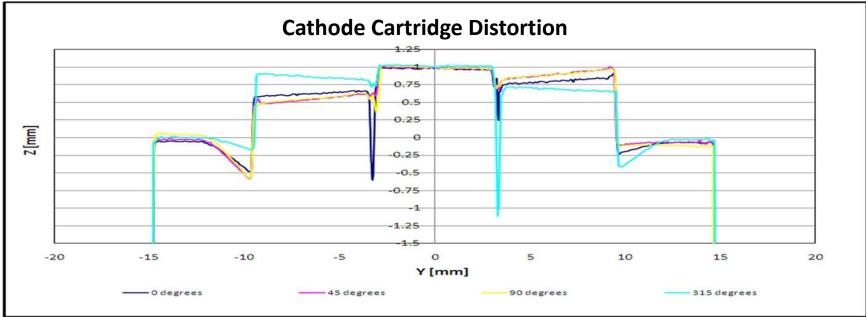
- Inspection of cathode cartridges revealed distortion
- Rf gun mating surfaces suspected to be distorted as well
- Cathode mating surface difficult to reach, 75 mm in from flange opening

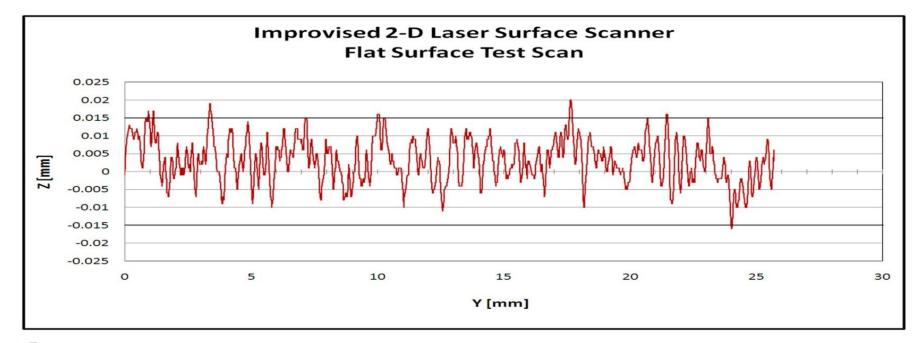
- Accuracy initially estimated to be +/- 5 μm
- Further analysis indicates accuracy is closer to +/- 15 μm
- Decrease from initial estimate attributed to noise produced by the motion of the sensor head during translation
- Accuracy might be improved through refinements in motion control for the translation

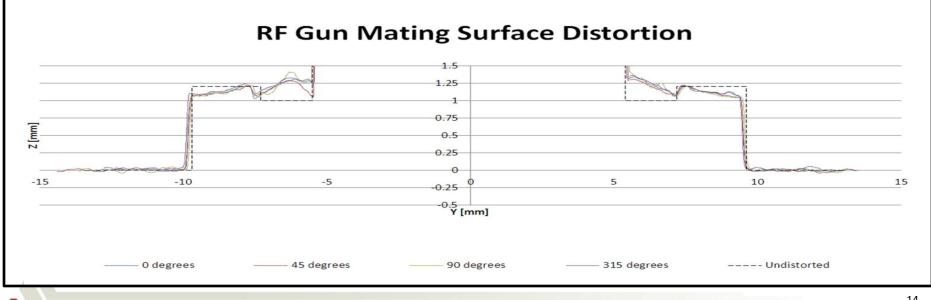
- Coordinate plots revealed distortion.
- Flat mating surface seals rf cavity from leakage and acts as a thermal and electrical conductor.
- Distortion caused by over-tightening of eight #4-40 screws that secure the cartridge within the gun body; now thought to have originated with the vendor.
- Source of problems discovered, but what now?

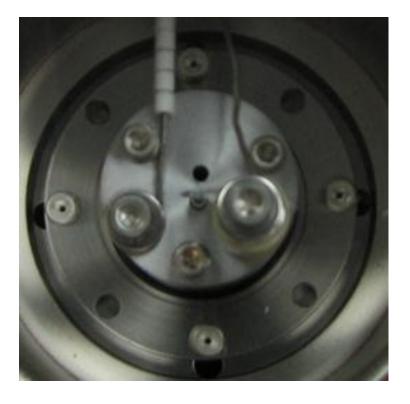
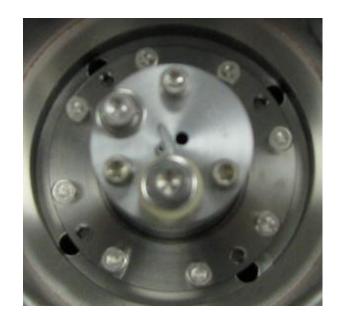
- Damage caused by over-tightening the cathode cartridge
- Torque of 0.2 inch pounds will deflect surface by 25 μm

- Screws seated against primary retaining ring with little / no torque applied
- Second retaining ring screwed to primary ring, clamping the eight primary screw heads between the two rings
