Newport Kappa Diffractometer Incident at 7ID-C

Don Walko, MHATT-CAT
Sector 7, XOR, APS, ANL
d-walko@anl.gov

Presentation for APS Technical Working Group, 10/16/03

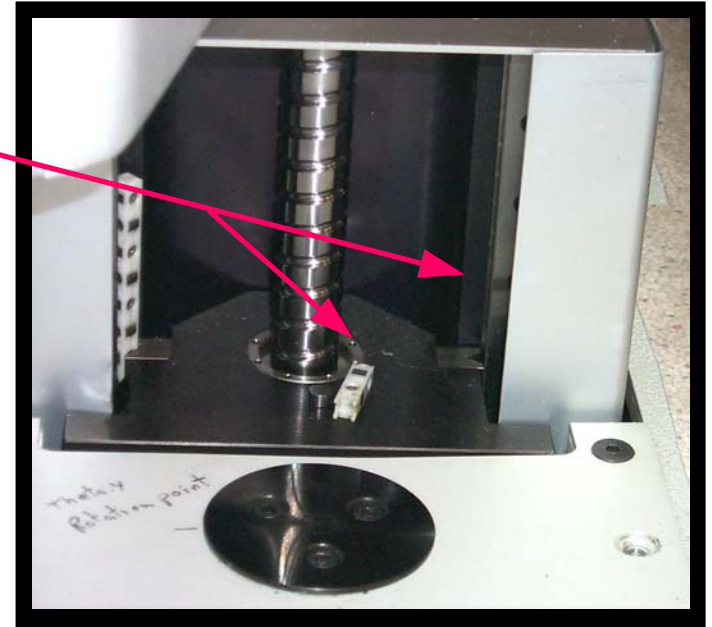
- 8/1998: Installation & acceptance
- 5/2001: Damage from overtilting:
 - Slides (V grooves and crossroller bearings) damaged
 - “Tilt” limit switch had been installed backwards! Once tilted too far, could not make level again.
 - Newport repaired at MHATT-CAT expense

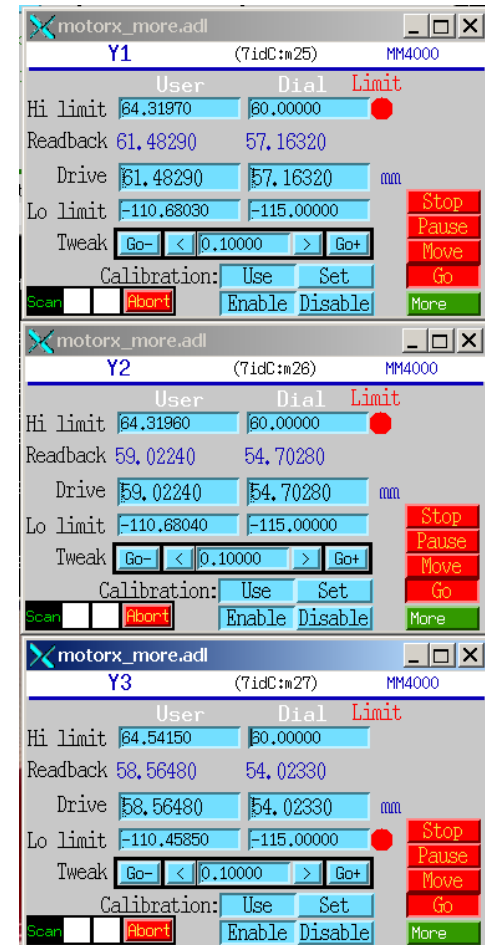
- To grease the slides, first moved kappa to (approx.) lowest allowed position & greased exposed V grooves
- Then moved to approx. highest position: All three motors were moving together to +59.9 mm (upper limit is +60 mm); kappa was basically level
- When jacks were almost to their highest point, heard a *crash*

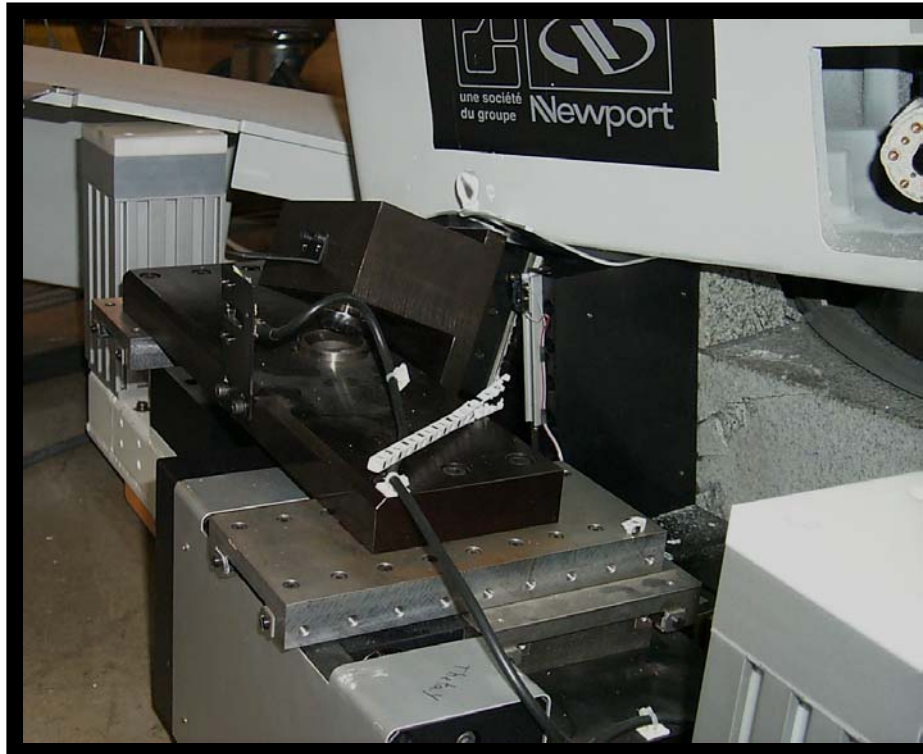
The damage: Y1 jack failed & the diffractometer fell

- Small aluminum retaining nut failed
- Without retaining nut, nothing keeps diffractometer from falling
- Possible that slide started failing first (& increased load on retaining nut)
- leadscrew split when pushed from side while diffractometer was collapsing (ie, secondary effect)
- Note that Newport has apparently been redesigning their jacks and even retrofitting other diffractometers

- Redesigned Y1, Y2, and Y3 jacks (no cross-roller bearings)
- New granite base
- Other repairs of secondary damage (fiber optic, base cover) and any hidden damage
- Careful assessment of bearing damage and realignment of all axes; replacement of damaged circles if necessary

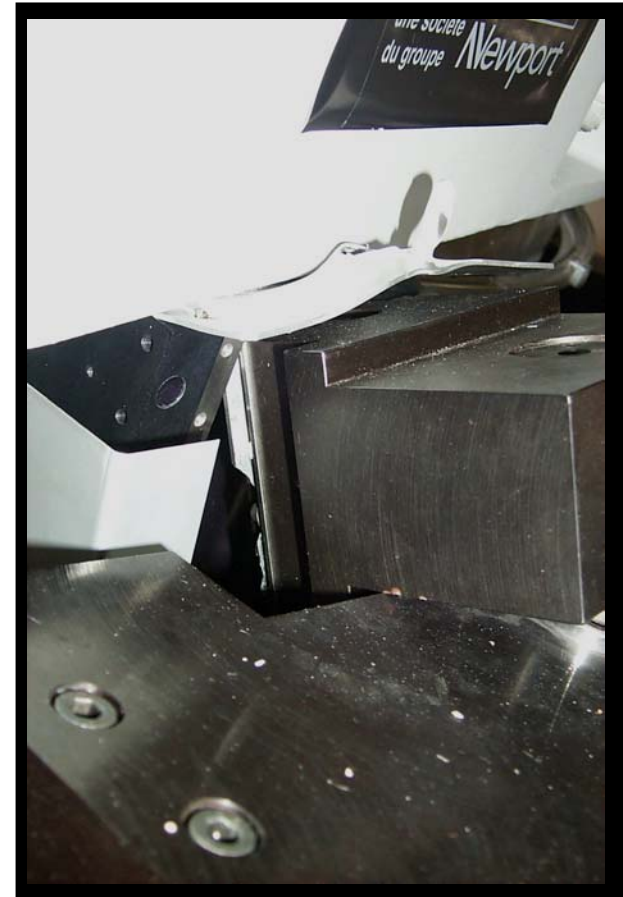
Y1 jack severely damaged,
granite base cracked

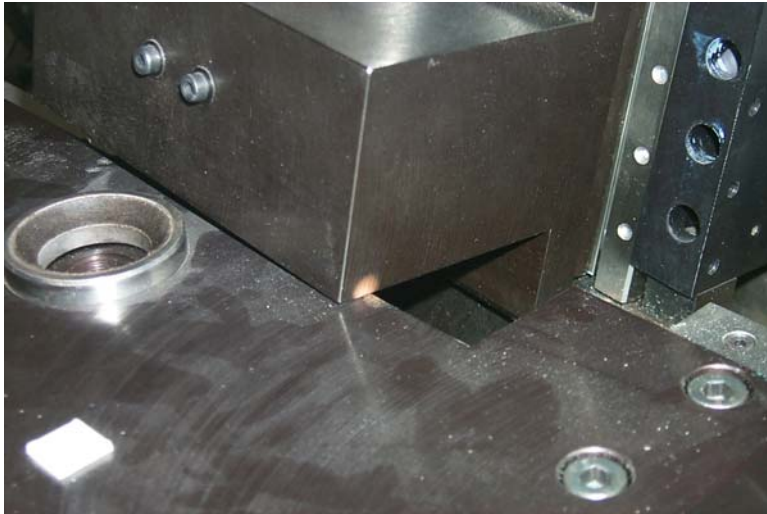
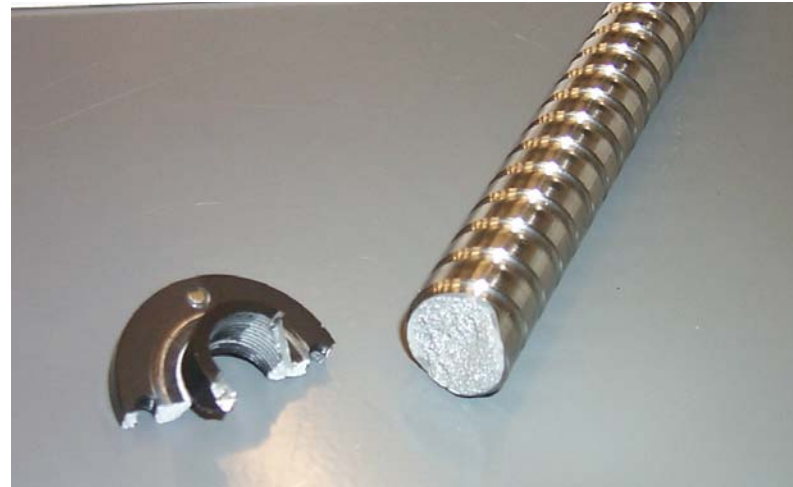
More views of the damage

- The Y2 jack was lifted off its seat, resting on a corner (Y3 was still seated)
- The Y1 leadscrew snapped in two
- Y1 retaining nut in several pieces

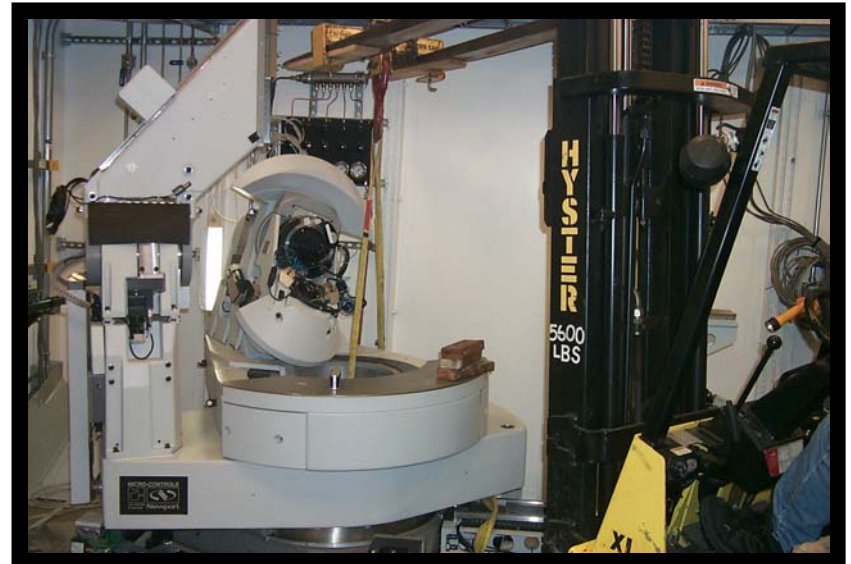
- Jaques Bosse from Newport visited over weekend of 10/3-5/03
- ANL Riggers lifted and stabilized kappa; blocked it up on wood
- Kappa was then floated outside of hutch on its airpads
- We need to quickly commission another diffractometer to use in 7ID-C until the kappa is repaired
