# ***Radiation Damage to Undulators at the APS***

*Liz Moog*

*International Workshop on Undulator Systems for Free Electron Lasers (WUS)*

***Argonne National Laboratory***

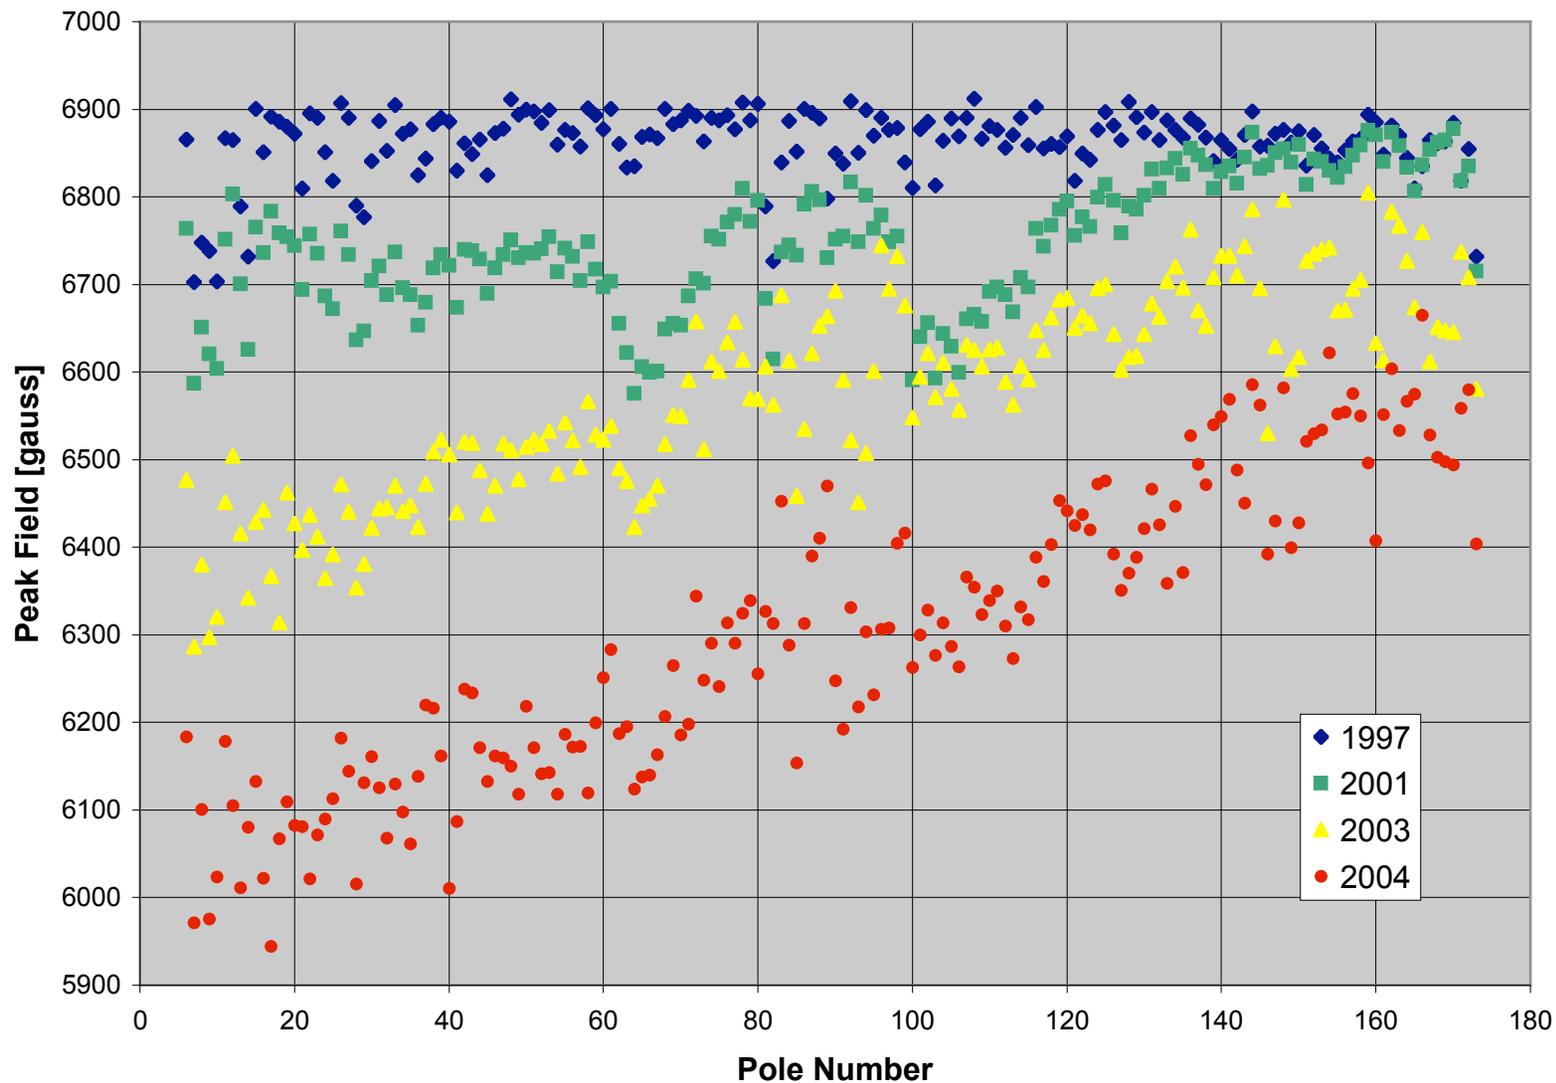
# Damage sequence in downstream ID, Sector 3

- **Two sectors (Sectors 3 and 4) have 5 mm vertical aperture vacuum chambers. (Usual is 8 mm.)**
- **Since top-up began in 2001, undulators in those sectors have been suffering significant radiation damage.**
- **M. Borland and L. Emery determined, through simulations and experiments, that the limiting horizontal inboard aperture in the ring for the topup lattice is in those sectors.**

- **A large part of the damage can be compensated by introducing a mechanical taper into the undulator.**
- **As the damage increases during a run, the users adjust the mechanical taper to restore the beam intensity.**
- **During shutdowns, I. Vasserman and S. Sasaki have performed additional tuning.**

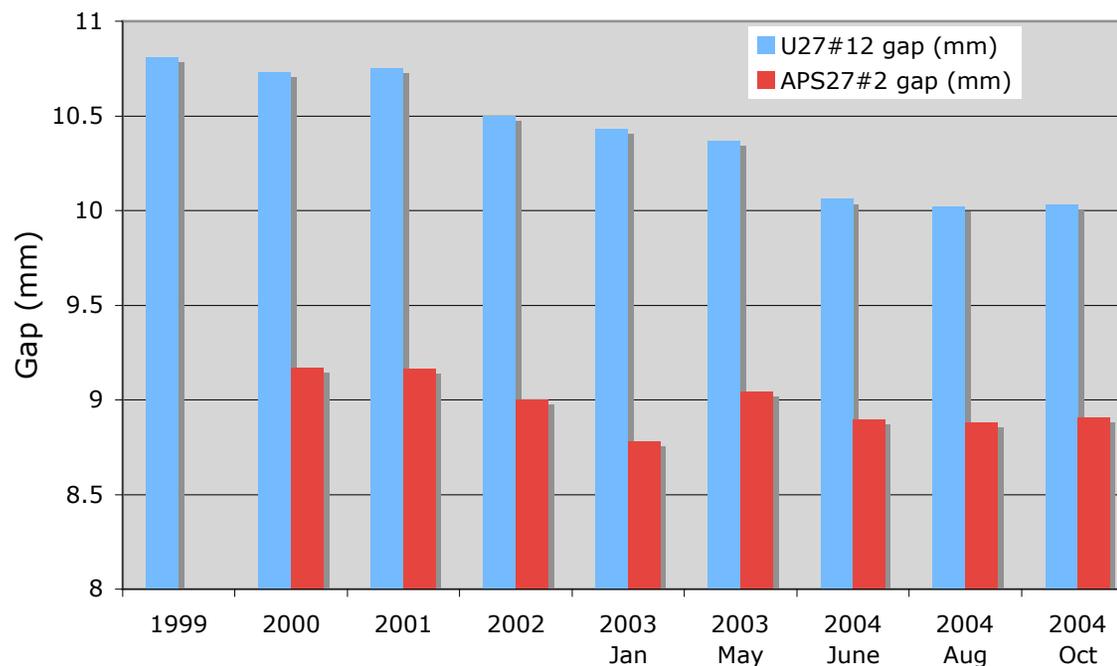
# Sector 3: Gap vs. time for 21.657 keV light

Year	U27#12 gap (mm)	APS27#2 gap (mm)	flux (arb.units)
1999	10.81		1.3
2000	10.73	9.173	1.3
2001	10.75	9.164	1.2
2002	10.5	9	1.1
2003 Jan	10.43	8.78	1
2003 May	10.37	9.045	1.3
2004 June	10.06	8.896	1.2
2004 Aug	10.025	8.88	1.2
2004 Oct	10.035	8.91	1.2

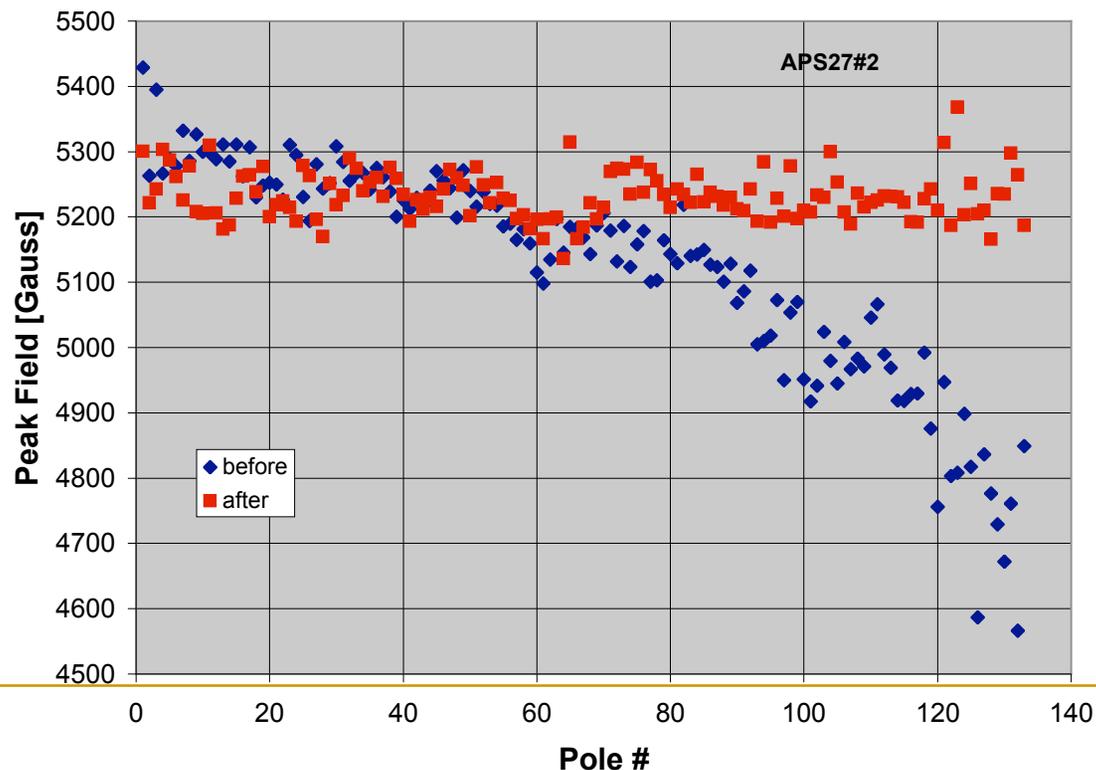
# *First major repair to undulator*

Damage to the upstream Sector 3 undulator reached the point where users could no longer close the gap enough to reach the desired photon energy. The undulator was restored to full operation by:

- Replacing some of the worst magnets with unused spares
- Rotating other magnets to turn the damaged side away from beam
- Standard tuning techniques

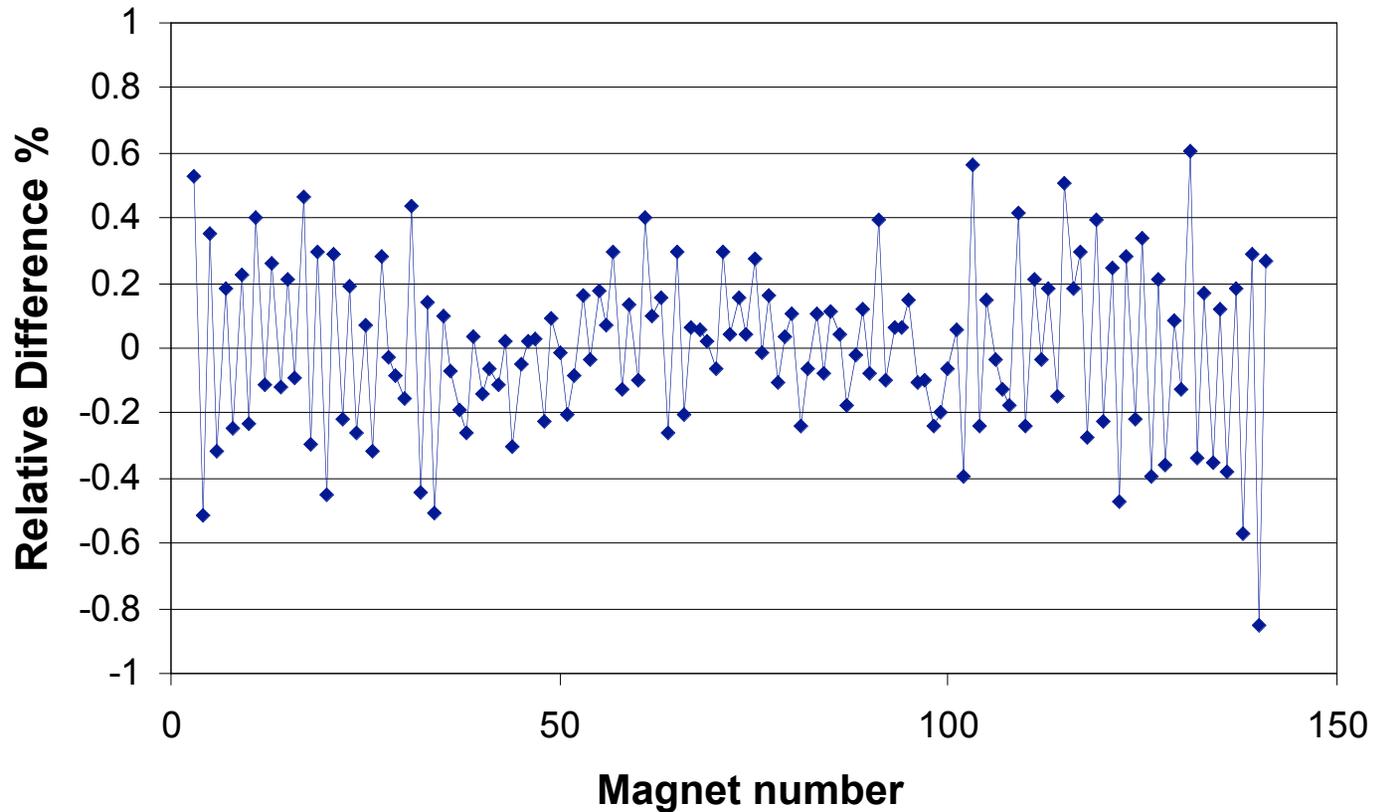
# *Uniformity of remagnetized magnets*

Magnets damaged in Sector 4 undulator were remagnetized. Uniformity of magnetic moment after remagnetization to saturation was very good

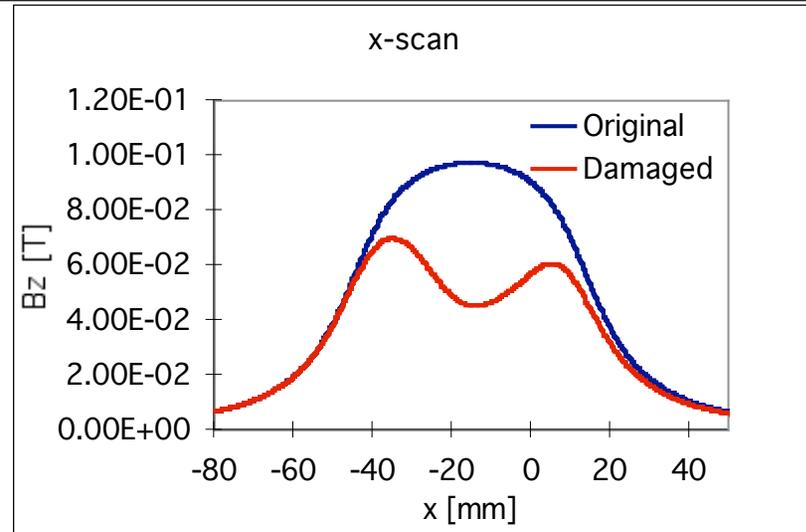
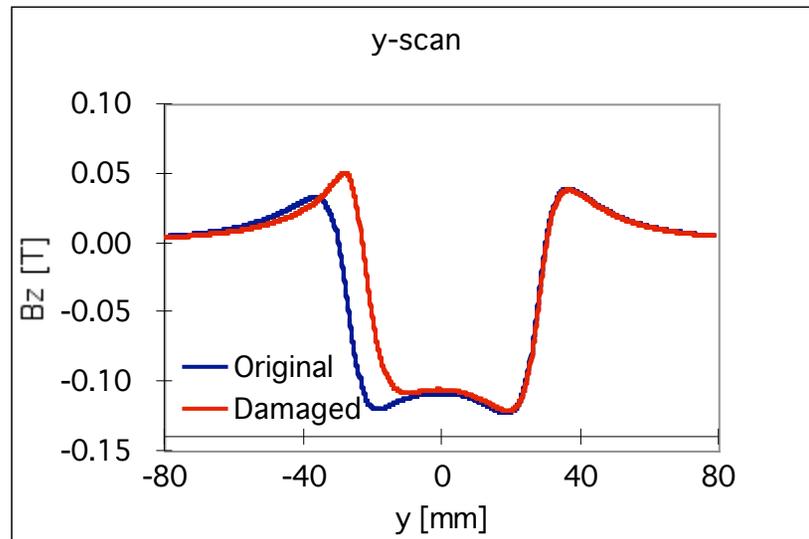
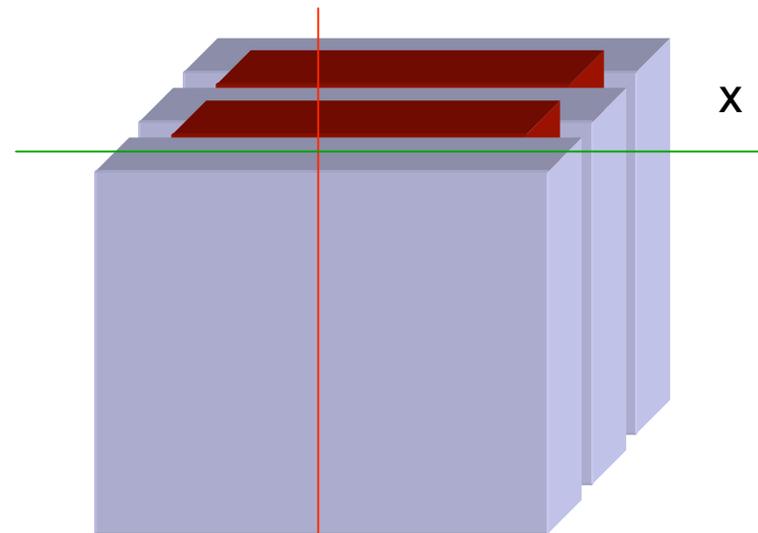
Magnet #6 from upstream end of upstream Sector 3 undulator

# Damage distribution in magnet block

Hall probe scans were made along the surface of the magnet in x and y directions.

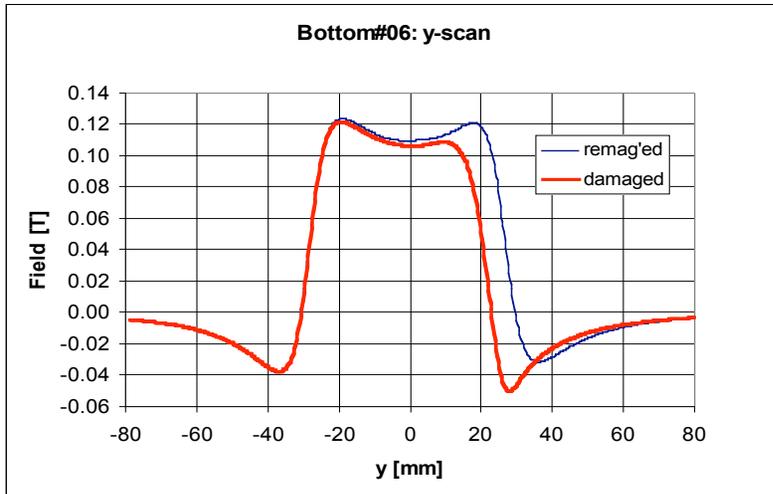
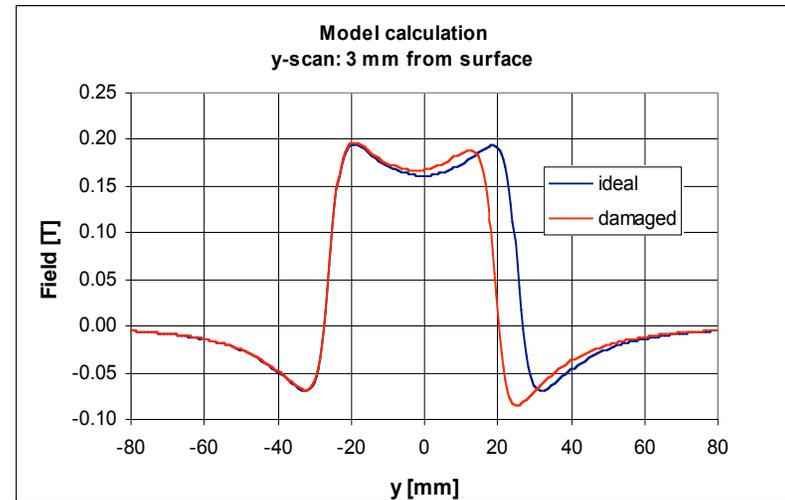
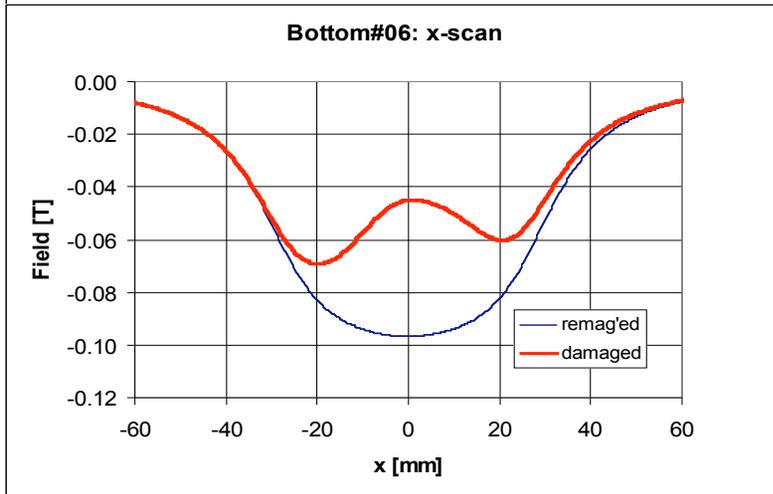
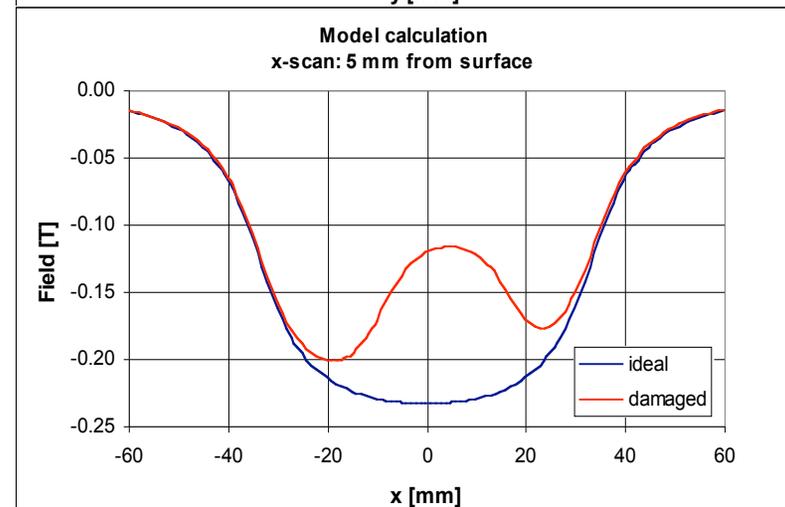
# Measured and fitted profiles of one magnet

Measured

Model calculation. Surface  $B_r = -0.1$  T, underlayer  $B_r = 0.1$  T

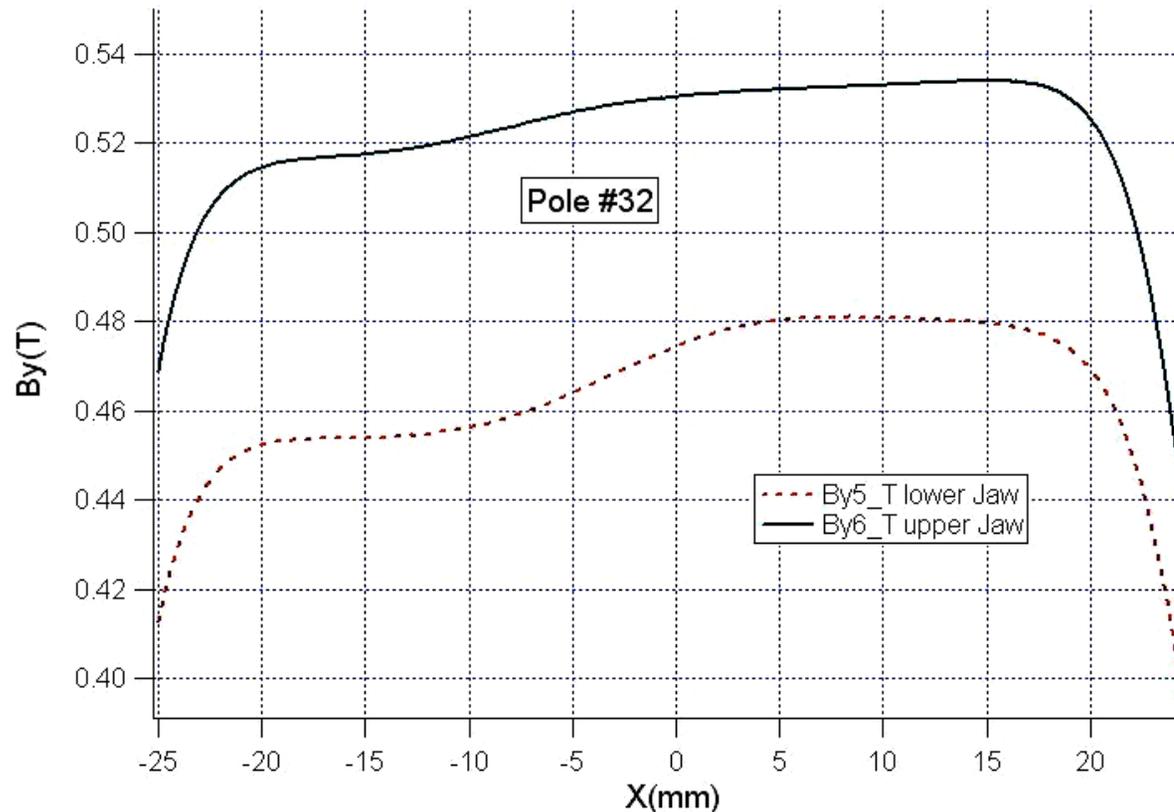
## Sector 4 demagnetization vs. $x$ : is the damage inboard or outboard?

In May 2004, the demagnetization was worse on the outboard side.

However, in Dec 2004 (above), demagnetization was worse on the inboard side.

In the most recent data, inboard damage is worse, consistent with scraping low-energy particles on the inboard side.

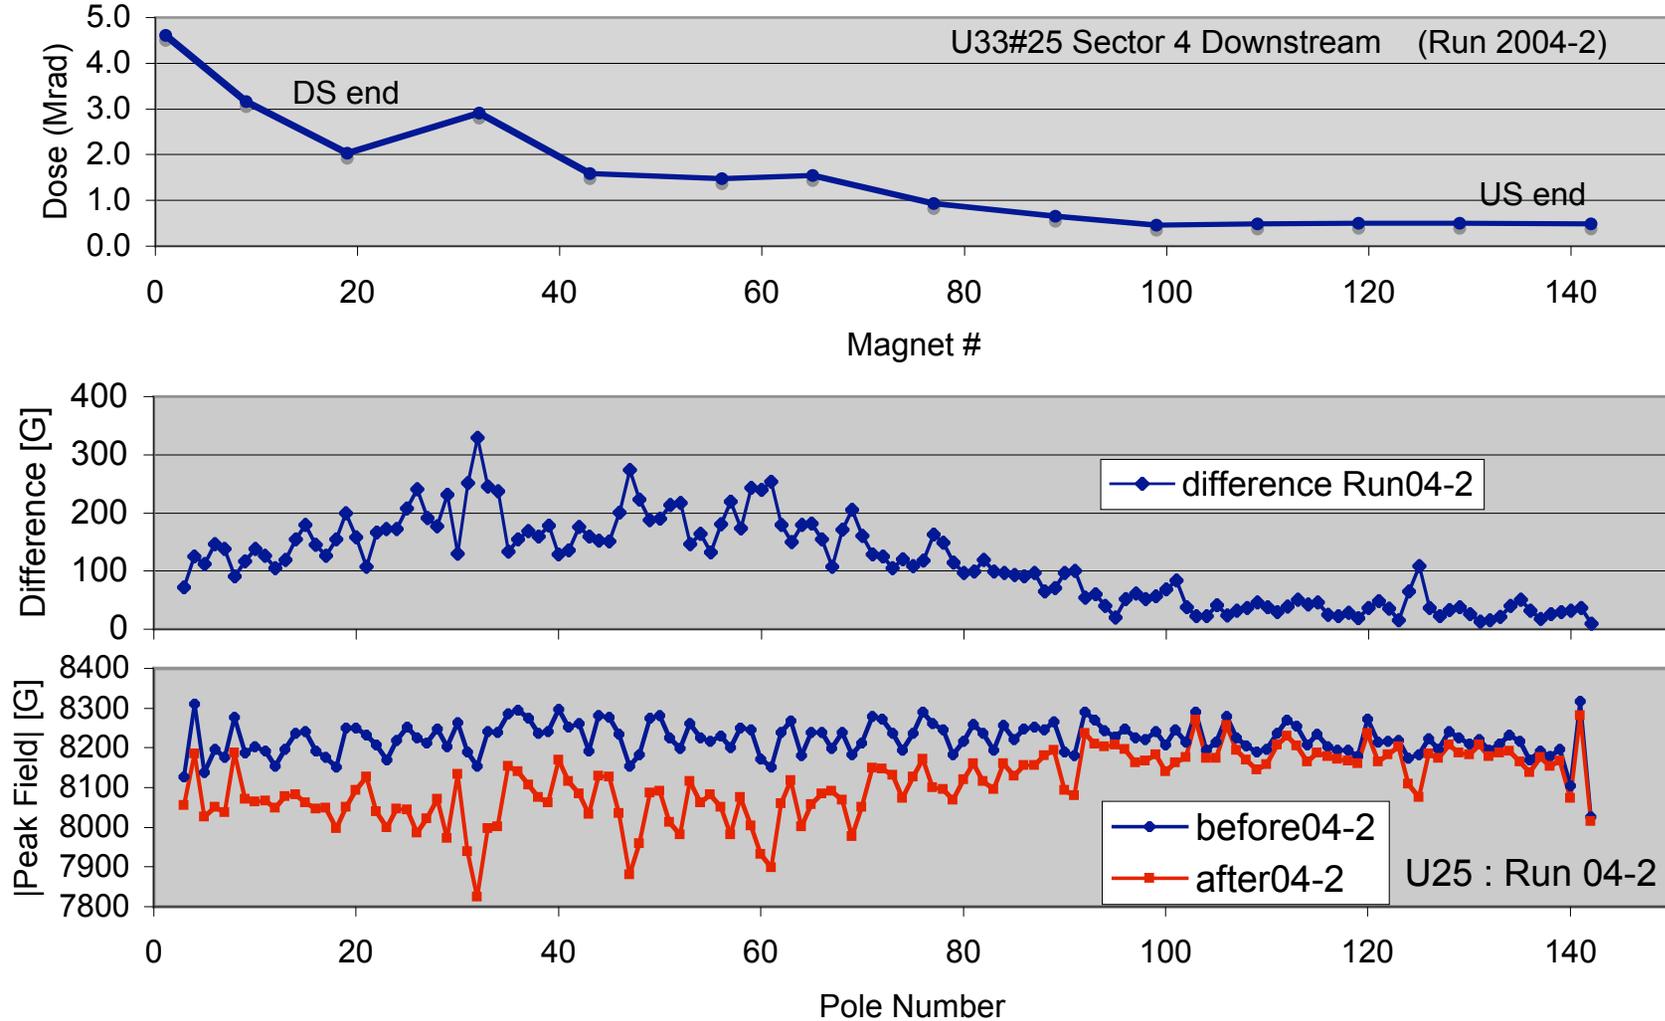
# Comparison of dose and field loss

**Attempts to correlate dose measurements to damage have not been as successful as we would have wished.**

**Sometimes there is some agreement but other times there is glaring disagreement.**

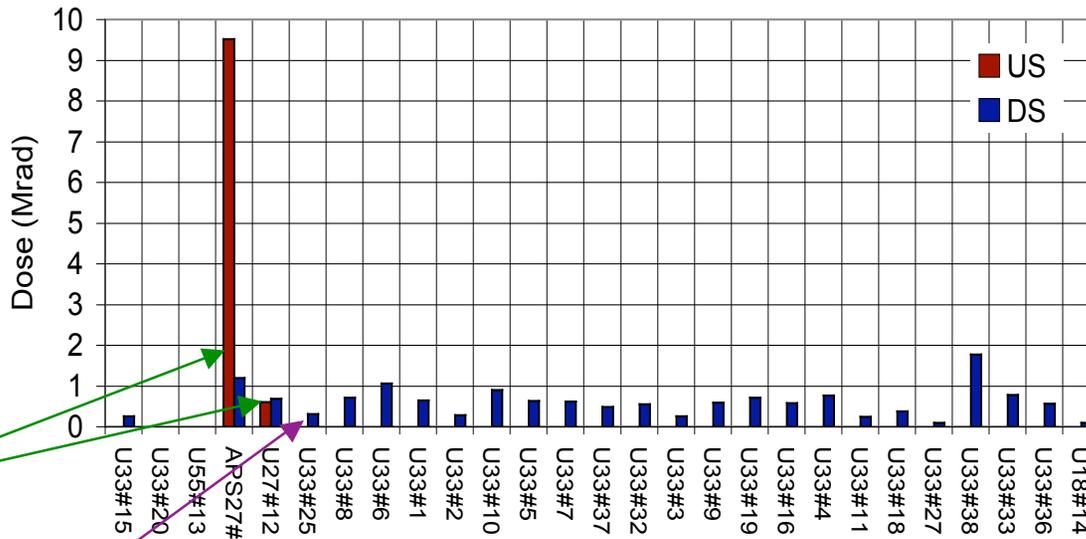
Run 2003-1

Doses in Sector 3 are typically very high. Doses in Sector 4 are low. Yet the damage rates are similar. Dosimetry is not measuring only what causes damage.
