# APS/Users Operations Meeting

# Recent Electrical Incidents

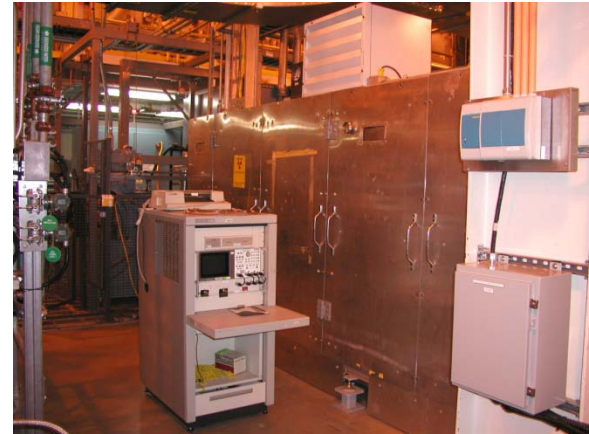
Technician leaned against network analyzer cart and grounded klystron housing – felt tingling sensation in elbow – 60 VAC differential between cart and grounded housing

- Both events were reported to DOE ORPS database.
- Shock was due to floating ground created from inadequate grounding – traced to how unit was constructed by manufacturer 15-20 years ago – had not been DEEI inspected prior to event - have now inspected similar units
- Short to ground was due to break in wire insulation – heat tape was not examined for flaws before being wrapped around component and energized – user's finger within 1 foot of spark so near miss
- User was not qualified to repair heat tape wire and then return it to service – should have notified beam line staff and used different heat tape “repaired” wire would not have passed DEEI inspection

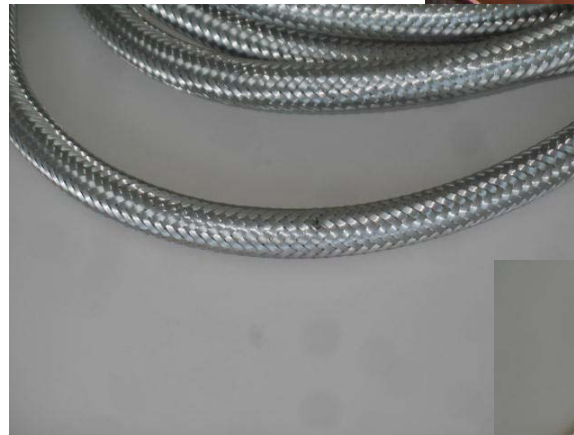
Graduate student user moved heat tape and it sparked – small arc flash burned hole in braided SS water line no shock

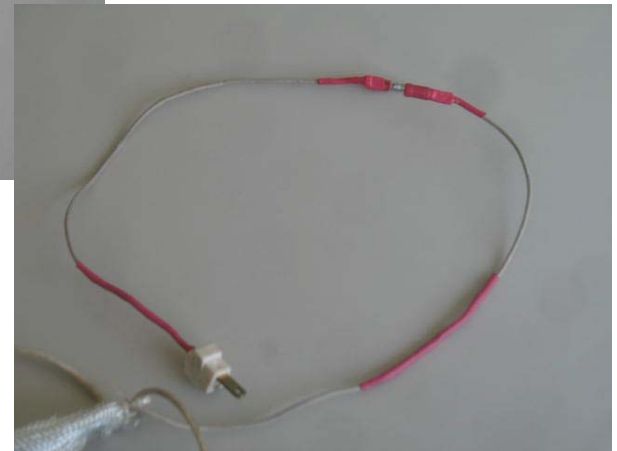
User then “repaired” the heat tape wire – returned to service without DEEI inspection

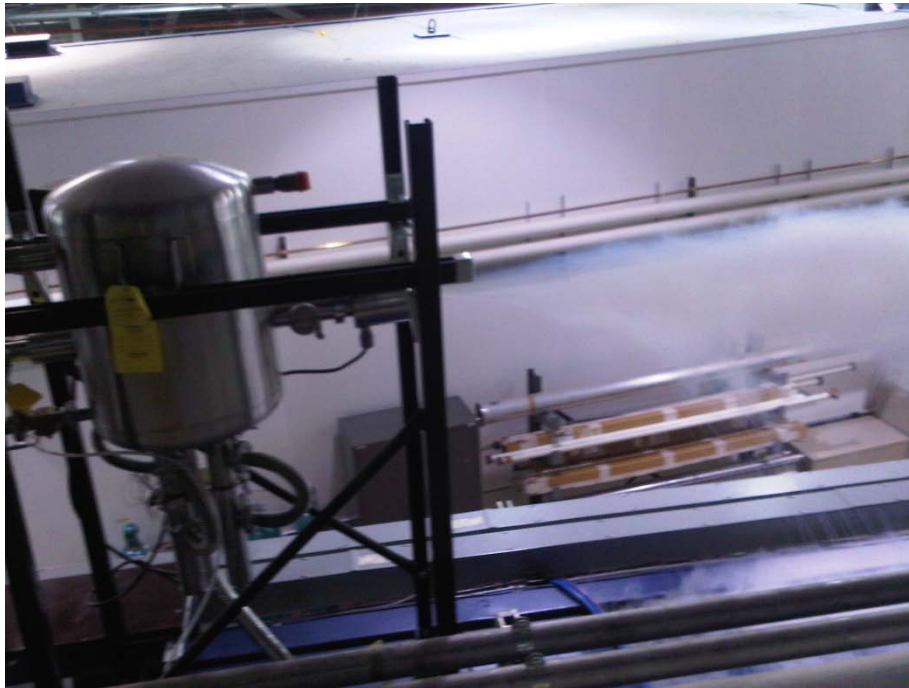
# LN2 Sector Hutch Top Spill

- Fill valve opened and failed to close for 10 hours.
- Minor cracks to hutch top.

- AES will review/improve LN2 alarm system. Two tier alarms to reduce nuisance alarms.
- The XSD Main Control Room crew has been trained to monitor LN2 parameters on off shifts.

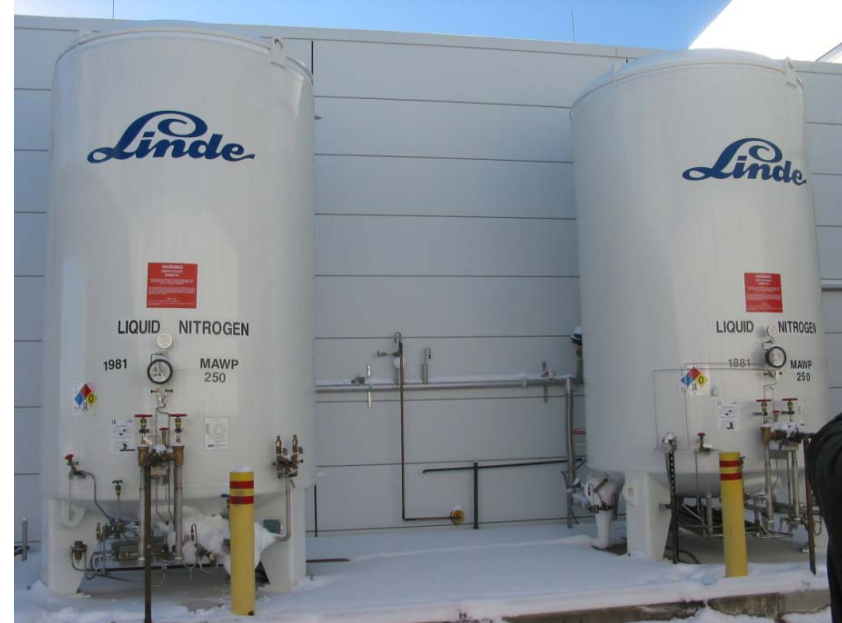
# LN2 Supply Dewar Low Level

## Consequence: Seven Sectors Effected

- **Causes:**
  - FMS failed to schedule Airgas for daily fill.
  - Low level alarm signal failed.
- **Corrective actions:**
  - AES, FMS, and Airgas will reconfirm daily fill.
  - AES will investigate replacement of existing 3000 gal dewar with a larger dewar.
  - AES will automate cross connect valves to open automatically.
