Old Design – Storage Ring Kicker Magnet

Upgraded – Storage Ring Kicker Magnet

Upgraded – Ceramic Vacuum Chamber

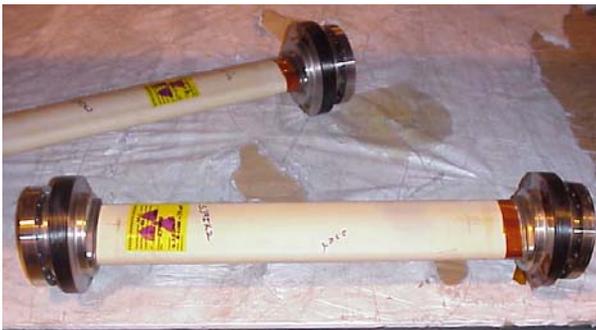
Old Design – Ceramic Vacuum Chamber

Older type ceramic vacuum chambers are designed with welded-bellows assemblies welded to both ends. The inside surfaces of the chambers were coated with a low-resistance conductive material. Resistance measurements of this coating indicate that the coatings were inadequate or damaged, which lead to an increase in temperatures on chamber walls during operations. Finger liners were ineffective in shielding the bellows as well as providing RF continuity.

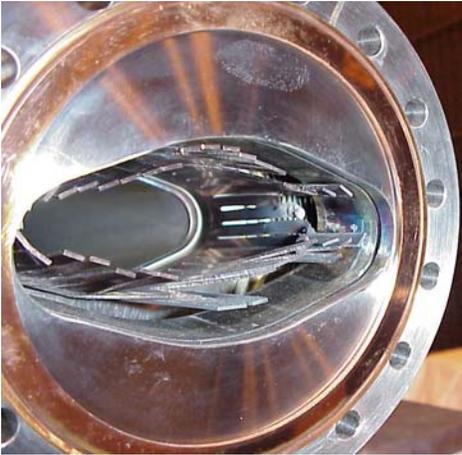
S38IK1 - Old Ceramic Chamber

Bellows are shielded with finger-type liners. Fingers at the outboard side of the downstream end of S38IK1 were damaged.

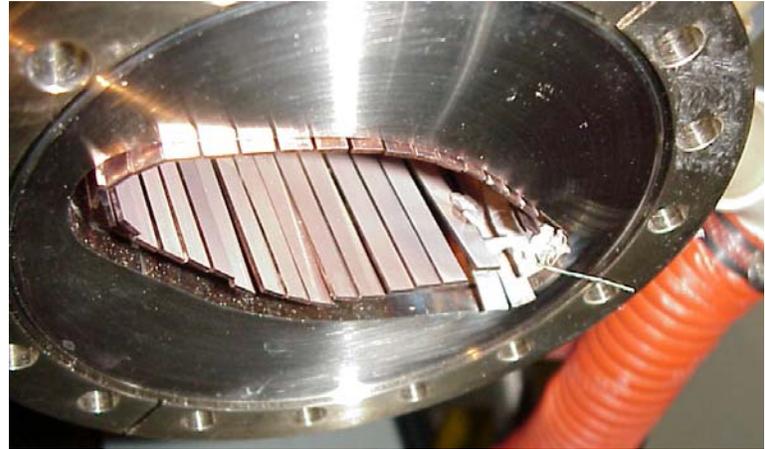
S39IK2 - Old Ceramic Chamber

Similarly, fingers at the outboard side of the downstream end of S39IK2 were damaged.
