# Care and Feeding of the APS 352-MHz/1MW CW Klystrons

*Doug Horan*

*APS RF Group*

*10/3/08*

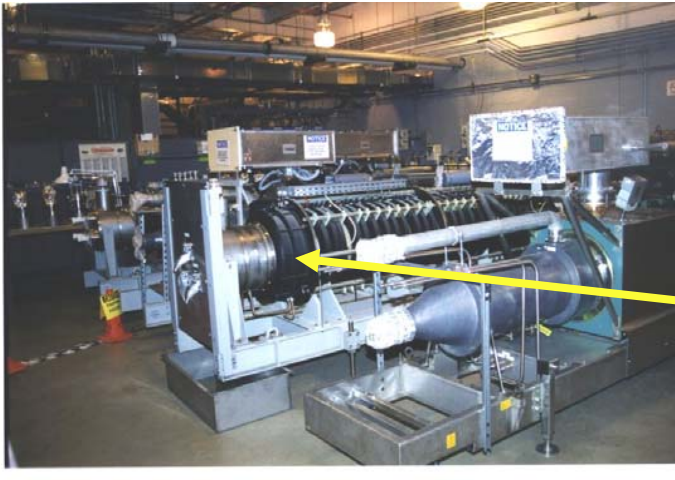
- Both klystrons are essentially the same in terms of electrical specifications, but differ slightly in length:

The EEV  
→  
is slightly  
shorter than  
←  
the Thales

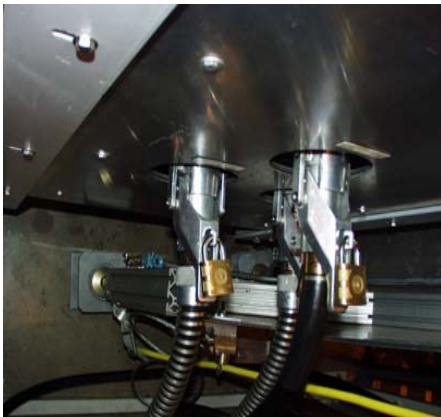
Thales Pantak  
connections are  
outside of  
the garage  
←

EEV Pantak  
connectors are  
inside of  
the garage  
→

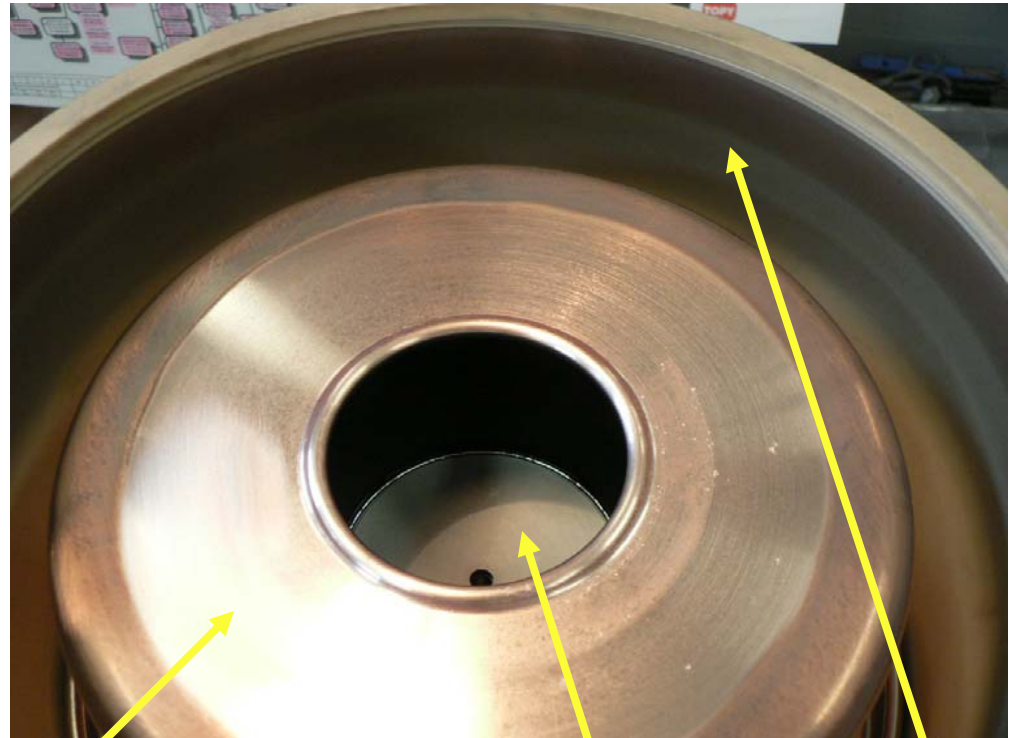
## Photo of Actual TH2089A Mod-Anode and Cathode

- Cathode assembly and emitting surface can be seen through beam hole in the mod-anode electrode.
- Under normal conditions, the mod-anode intercepts very little beam.
  - *Typical mod-anode current is 0.1-3mA depending on beam power and rf output.*
  - *Excessive mod-anode current can be a sign of sideband instabilities (“back-streaming” electrons) or excessive barium deposition on the gun ceramics.*

Mod-anode

Cathode

Ceramic

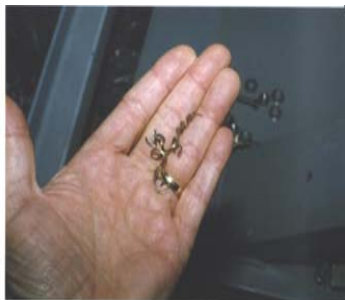
- Pipe thread cuttings clogged collector grooves and resulted in a hot spot which grew steadily worse due to ion-focusing.
- The ultimate result was the total loss of the klystron due to loss of klystron vacuum.

Foreign material  
found between  
collector and boiler

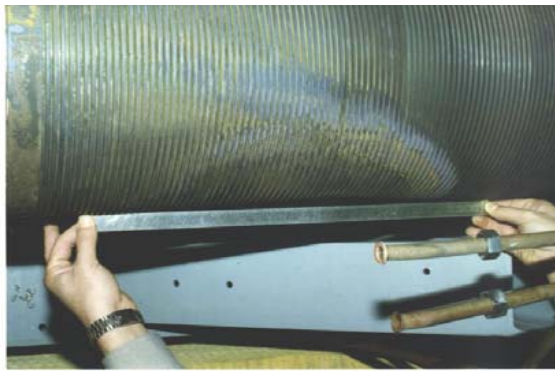
Distorted collector due to melting

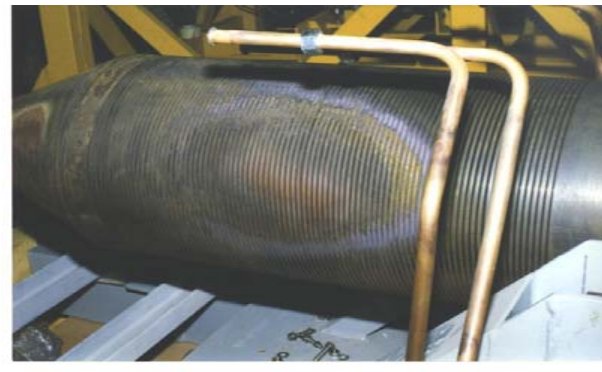
Overheated appearance on collector

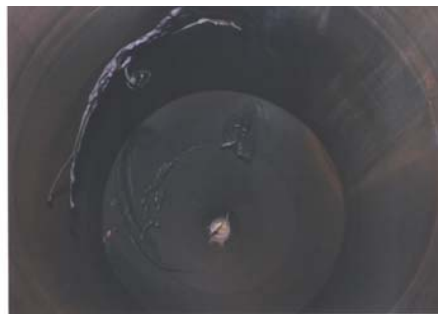
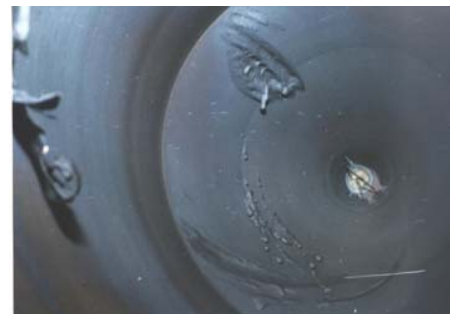
Melting on interior of collector

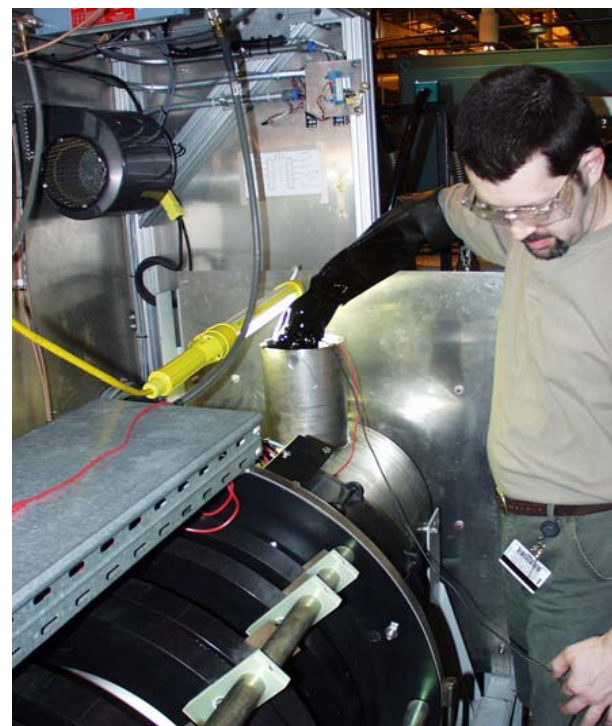
**Ground-stick terminals inside tank before entering!**

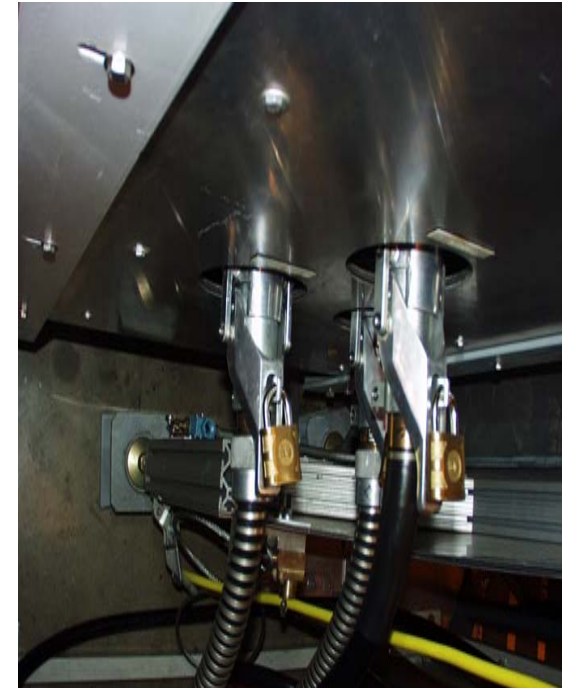
- Clean and re-grease all Pantak plugs and sockets  
→ NOTE: *If any oil is detected inside the Pantak socket when the plug is removed, the socket and/or gasket are leaking and must be replaced!*
- Check all ground connections for tightness

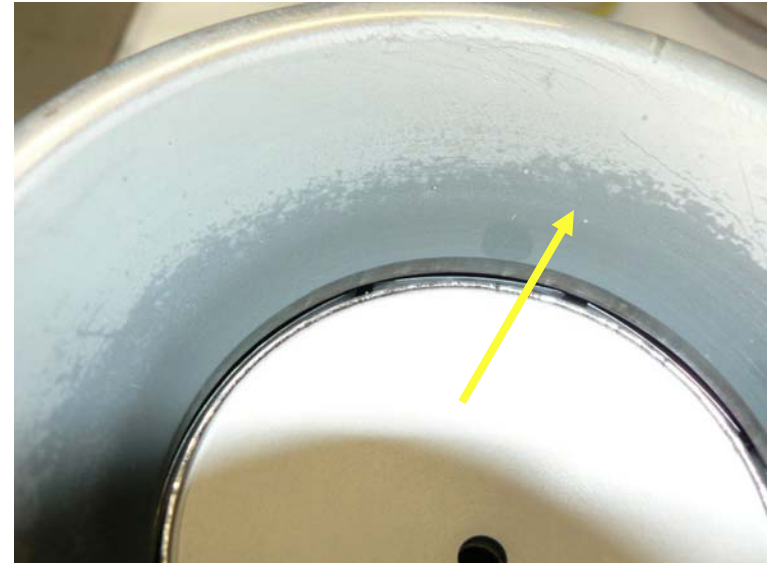
**Excessive barium on cathode  
whenelt electrode**

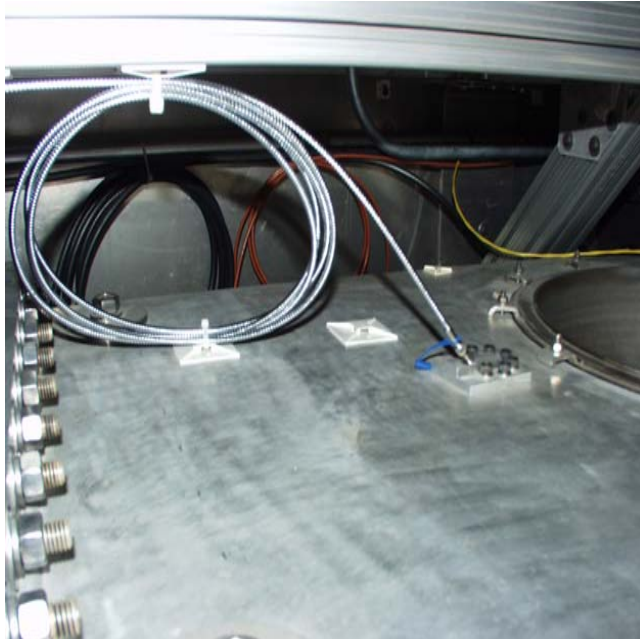
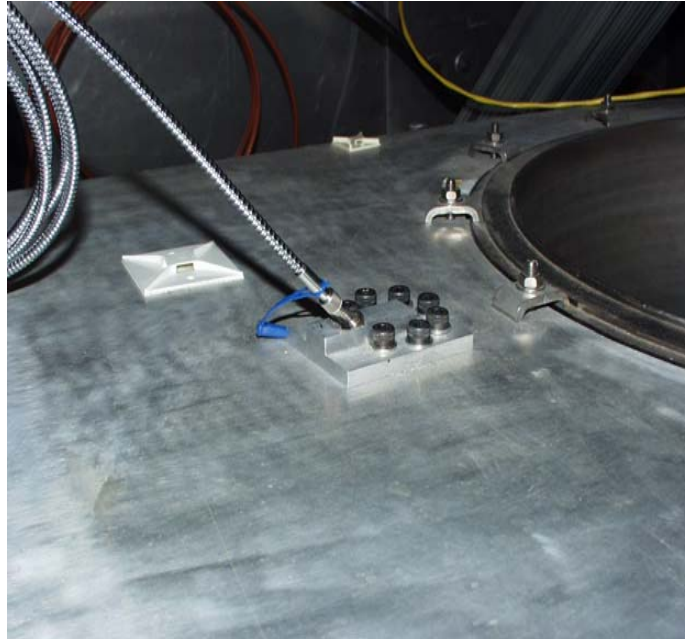
- Fast arc detection is *critically* important to prevent window damage!
  - *Test arc detectors routinely at the input of the fiber optic cable!*
  - *Verify that the fiber-optic cable is connected to the view port!*

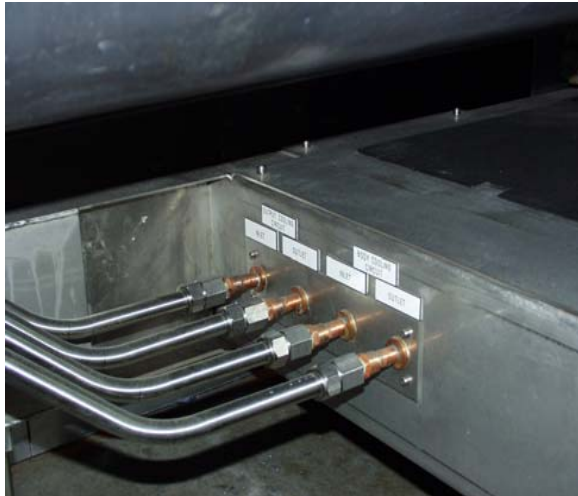
K3513A body and output  
Cavity inlets and outlets

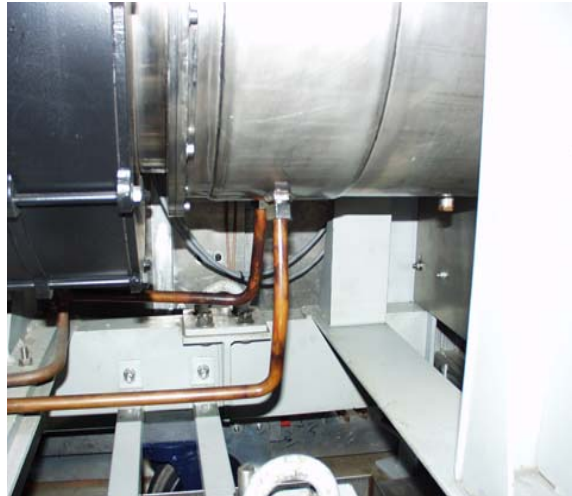
TH2089A oil tank water jacket

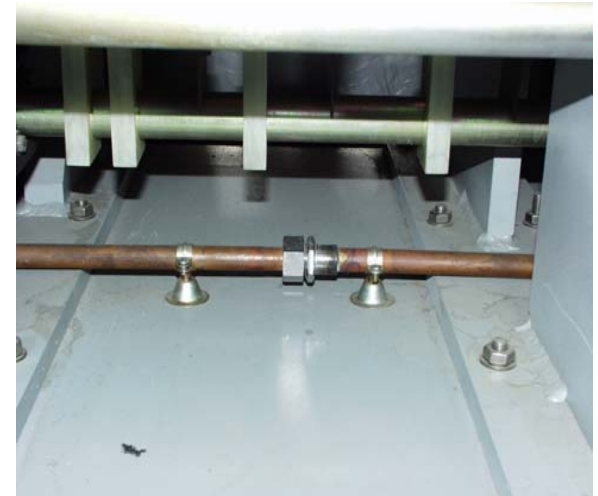
TH2089A body-1 water circuit

***Routinely check these connections for tightness!  
Replace gaskets if leaks persist!***
