RF Electron Gun Mechanical Repair

Bill Jansma, Engineering Specialist Advanced Photon Source Argonne National Laboratory

2013 APS Accelerator Systems Division Seminar Series

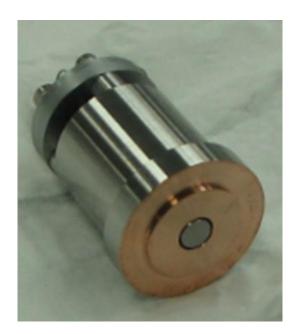
- Cathodes replaced in 2009; temperature and reflected power problems arose soon after
- Two rf guns failed in 2010 due to excess reflected power; spare rf guns were installed
- Further failures could limit capabilities; worst case temporarily suspend APS operations

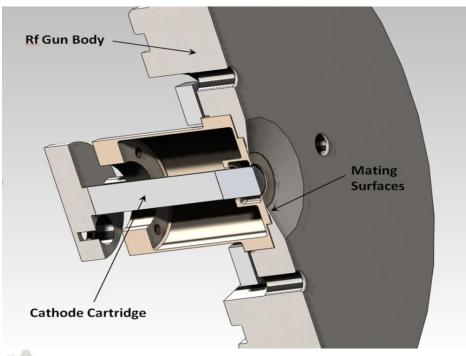
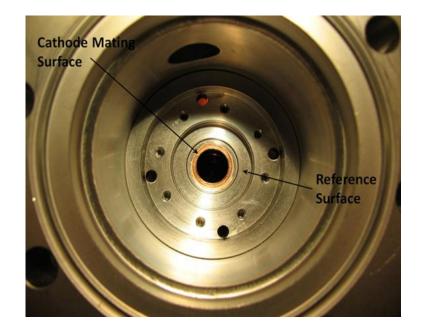
- Inspection of cathode cartridges revealed distortion
- Rf gun mating surfaces suspected to be distorted as well
- Cathode mating surface difficult to reach, 75 mm in from flange opening

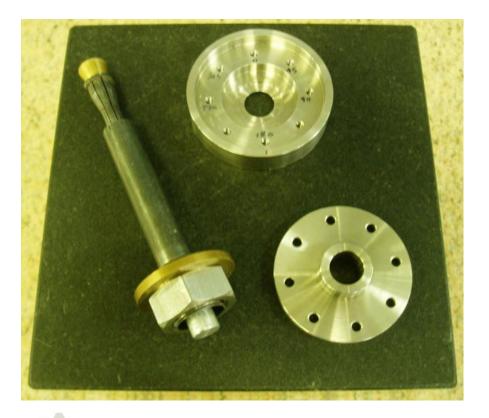
- Coordinate plots revealed distortion.
- Flat mating surface seals rf cavity from leakage and acts as a thermal and electrical conductor.
- Distortion caused by over-tightening of eight #4-40 screws that secure the cartridge within the gun body; now thought to have originated with the vendor.
- Source of problems discovered, but what now?

- Alternatives were explored including replacement, modification, and repair.
- Replacement and/or modification would be costly

- Decision made to repair the damaged guns
- Special retraction tool designed by E. Traktenberg was tested successfully on a mockup

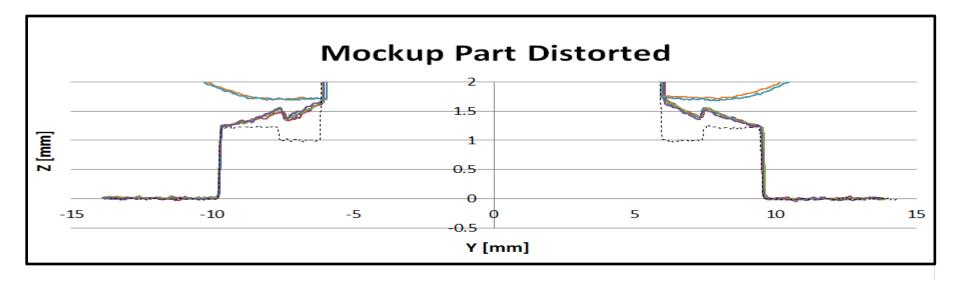
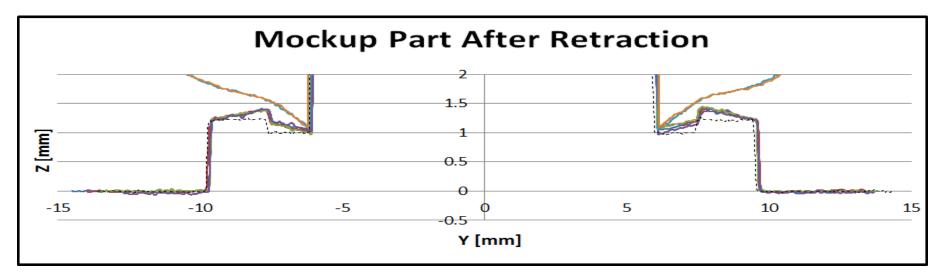
MOCKUP TEST RESULTS

- Efficacy of the tool proven in the mockup test
- Successful repair was performed on two rf guns in March / April 2011

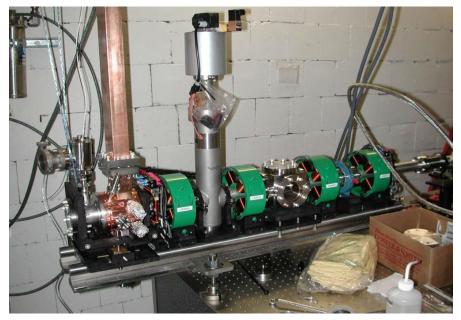
- After repair the rf guns were rigorously tested in the APS Injector Test Stand
- The 3G1 and 3G3 guns are currently being operated in the APS Main Injector

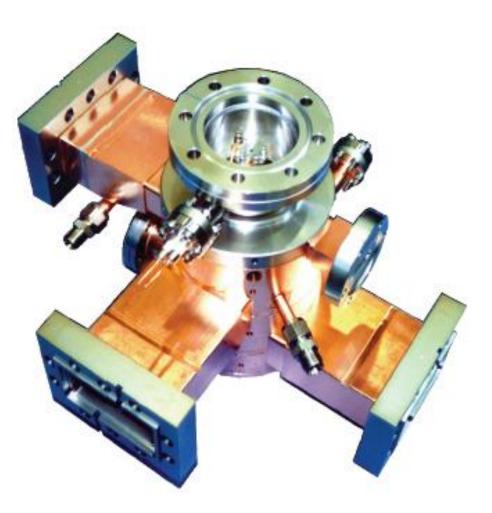
Ballistic Bunch Compression Rf Gun

- Two more rf guns underwent the repair process in 2012
- 3G2 and BBC guns had same damage to cathode mating surface
- Damage found in the 3G2 gun indicates problem originated at vendor; gun had never been opened by APS personnel
- BBC gun repair supports graphene window test
