Newport Kappa Diffractometer Incident at 7ID-C

Don Walko, MHATT-CAT
Sector 7, XOR, APS, ANL
d-walko@anl.gov

Presentation for APS Technical Working Group, 10/16/03

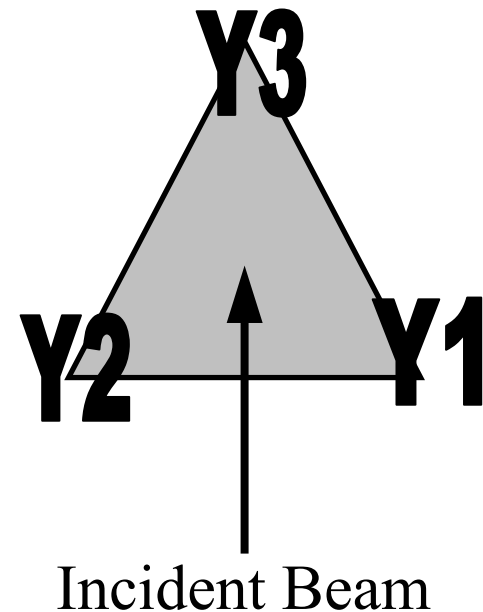
Top view of jacks:

- Newport kappa diffractometers are supported on three vertical jacks (Y1, Y2, Y3)
- Plus 2 horizontal motions=almost kinematic base (does not move parallel to beam)
- How the jacks work...

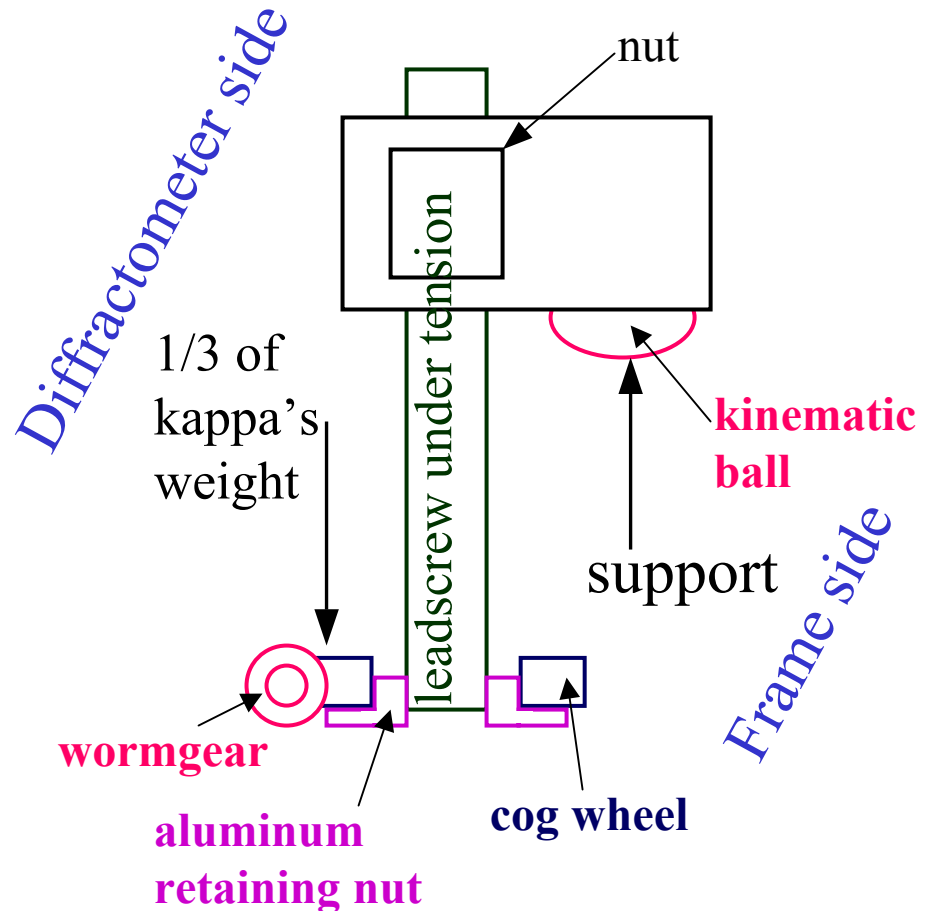
How the jacks work (highly schematic view):

- Stepper motor turns wormgear
- Wormgear rotates cog wheel
- Leadscrew is held to cog wheel by retaining nut
- Leadscrew--in tension--rotates and climbs up or down on stationary nut
- Slides: V grooves w/ cross-roller bearings
