# ***Radiation Damage to Undulators at the APS***

*Liz Moog*

*International Workshop on Undulator Systems for Free Electron Lasers (WUS)*

***Argonne National Laboratory***

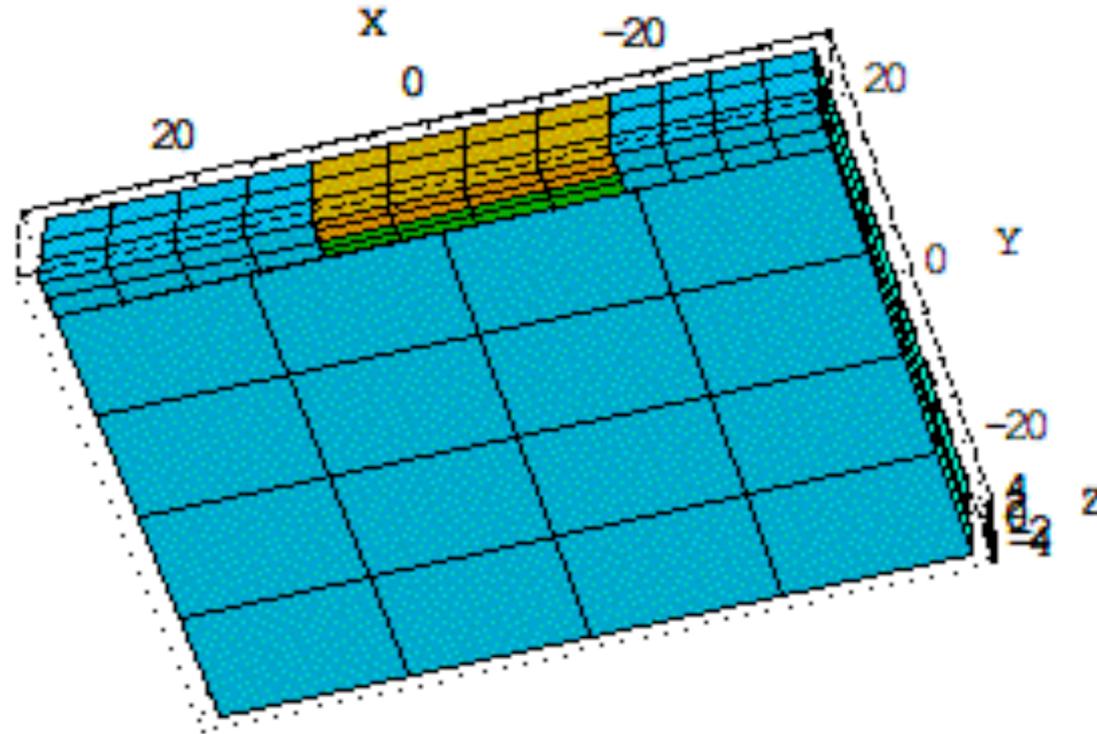
**Two regions in the magnet can be set to have a magnetic field strength different than in the body of the magnet, to simulate damage profiles. Each region is 3 mm thick.**

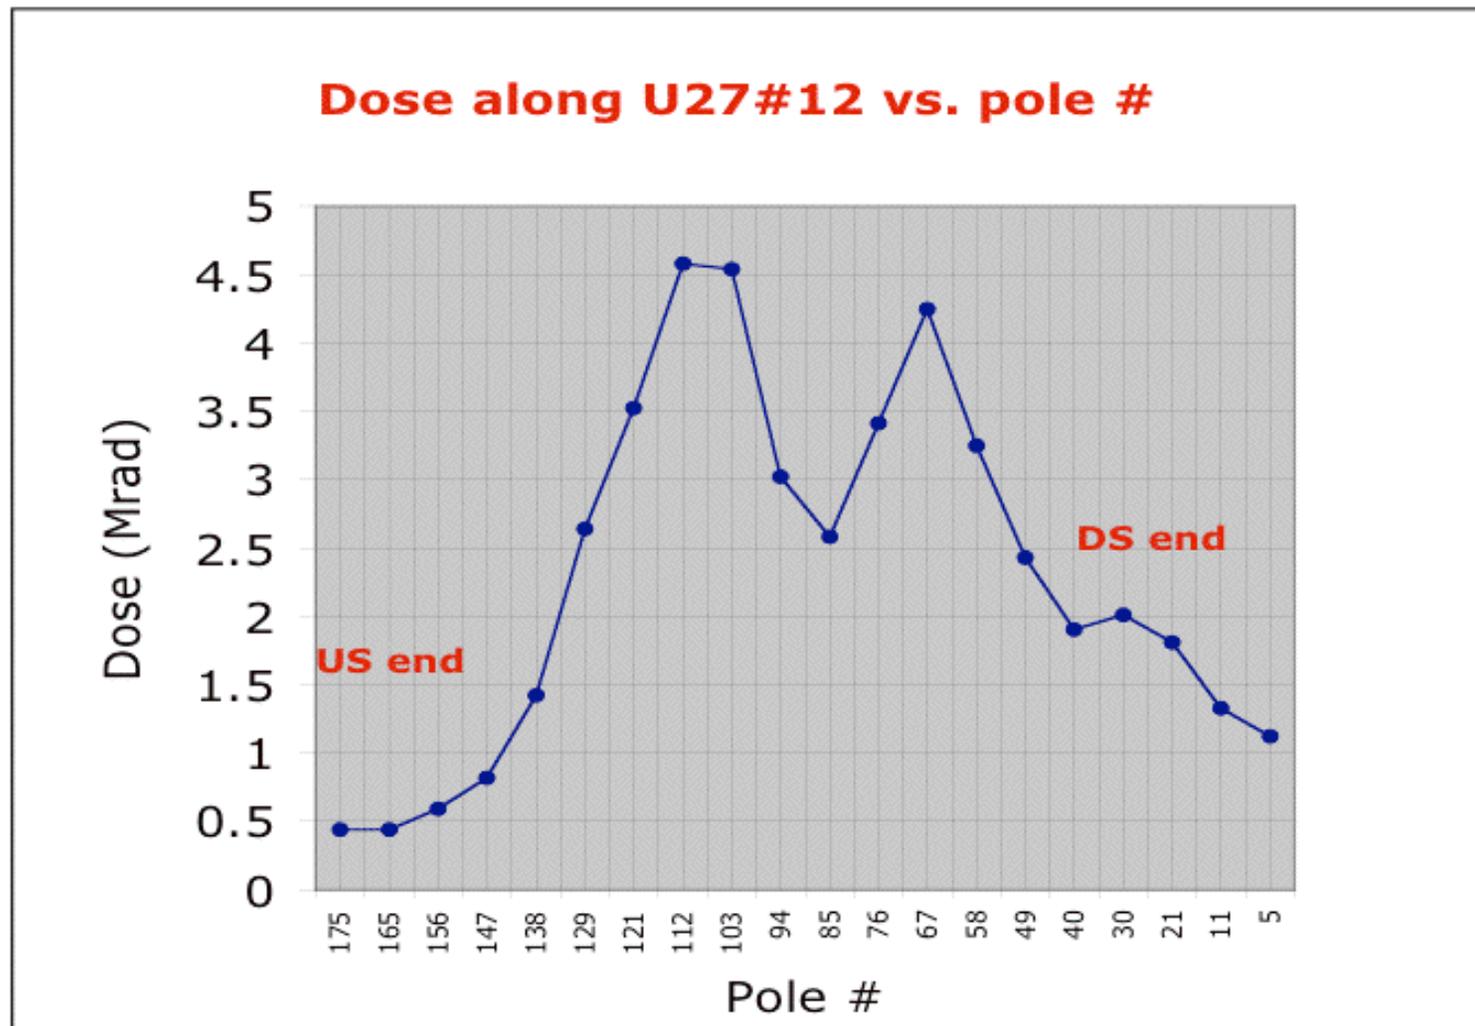
# Dose profile along downstream Sector 3 ID

Doses in Sector 3 are typically very high. Doses in Sector 4 are low. Yet the damage rates are similar. Dosimetry is not measuring only what causes damage.

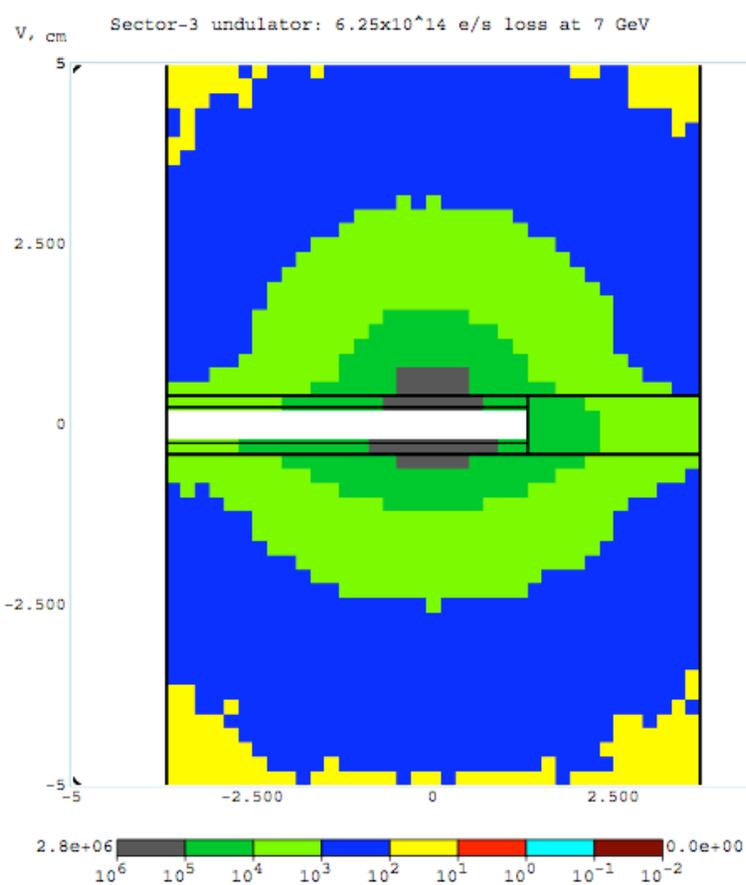
**Electron dose**

Assuming  $6.25 \times 10^{14}$  e/s loss at 7 GeV.
