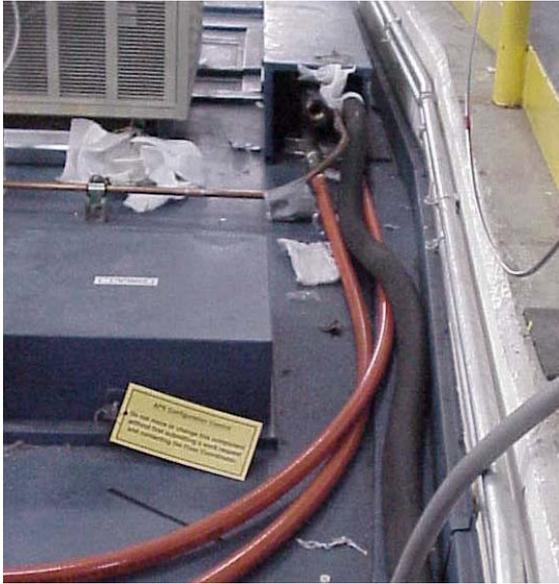
Fig. 2A: Vent line extension in Sector 20 after completion.

Technician fashioned an extension for the vent line from Armaflex type insulation and connected it to the end of the line used for the vent. A photo of the modified vent line is shown in Fig. 2.

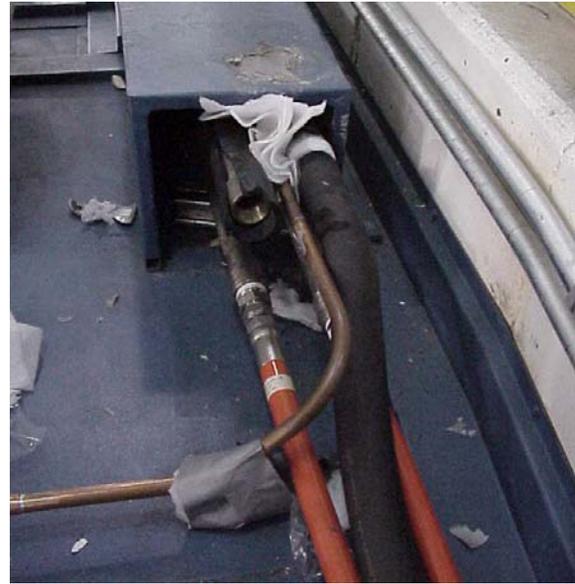
The technician noticed that the cold nitrogen gas was discharging directly onto the DI water line also passing through the labyrinth.

Fig. 2B: Close-up of vent line extension in Sector 20 (orange hoses are DI water lines)
