Date: April 15, 2004

Subj: APS drawings [25030101-00014](#) PAR flag/tuner chamber S-6
[25030101-200000](#) PAR spare chamber SP-6 (spare flag)

Spare status: Spare chamber SP-6: chamber design complete;
Beam tube being fabricated

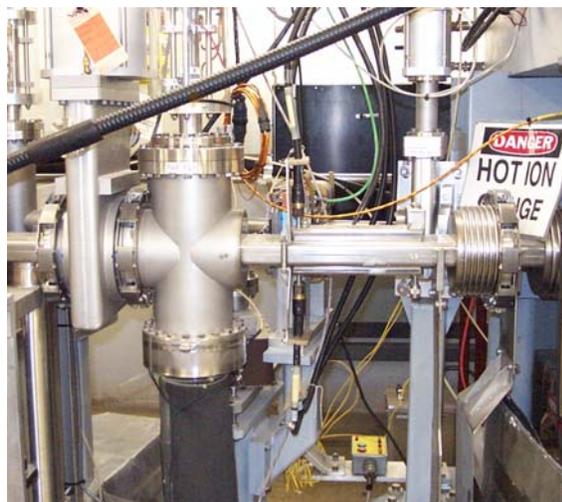
Fig. 3: S-6 flag/tuner chamber installed in PAR

This chamber is installed in PAR in one place as shown in Fig. 3 on extraction side of septum.

Use spare vacuum chamber SP-6 (APS drawing [25030101-200000](#)) to replace an original S-6 chamber if necessary.
