TECHNICAL NOTE FOR REPLACING 352MHz RF CAVITY TUNING COMPONENTS

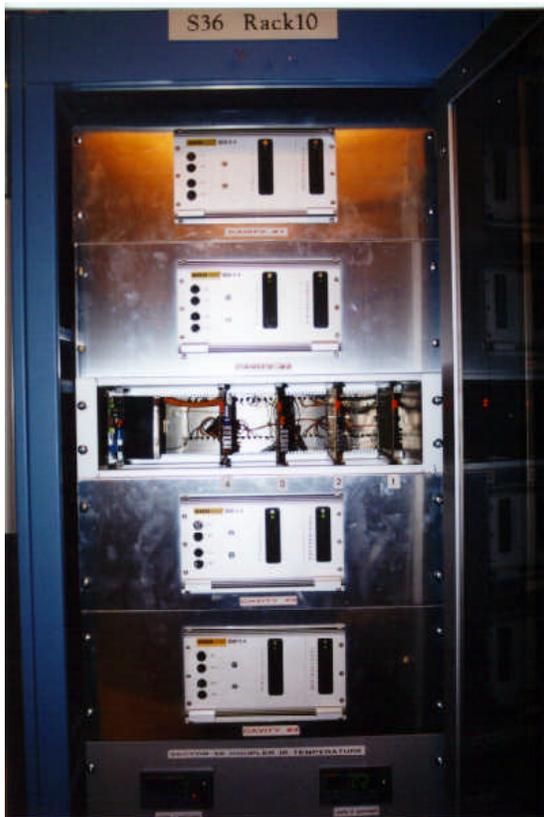
1. Turn of the rf drive to the rf station that is supplying rf power to the cavity where tuner components are to be replaced.
2. Remove the ac power from the Berger-Lahr Motor Control modules (see Figure 1 and 2).

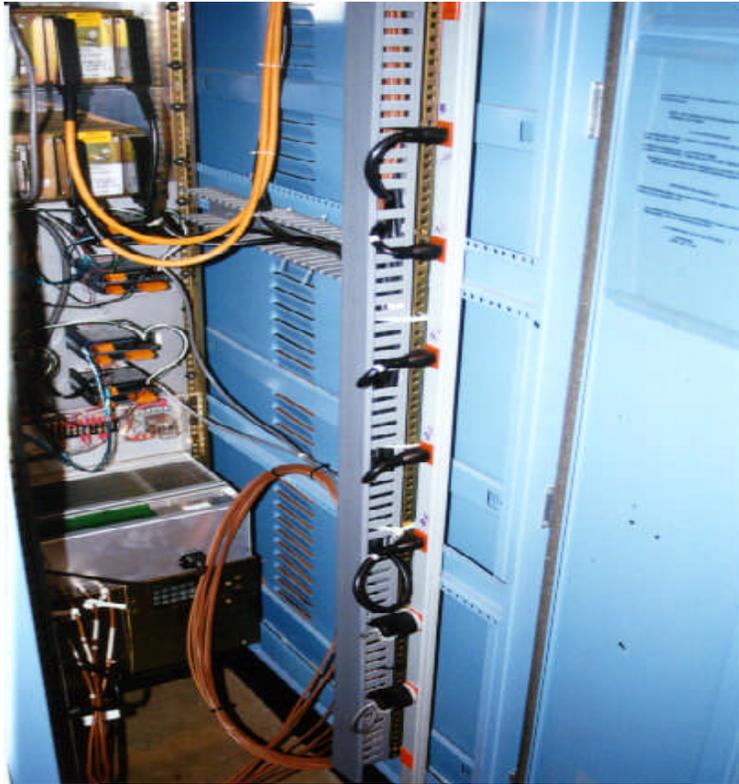
Figure 3

Note: If this activity requires working on or near the tuning motors themselves in the accelerator tunnel, the ac power to the Berger-Lahr motor control modules must be locked-out using LOTO cups over the line cord plug for the appropriate module before coming into contact with the tuner motor or it's mechanical drive components (see Figure 3).
